# Experimental Investigation on Condition Monitoring Opportunities of Tramway Tracks

62(1), pp. 180–190, 2018

Ákos Vinkó<sup>1\*</sup>, Péter Bocz<sup>1</sup>

RESEARCH ARTICLE

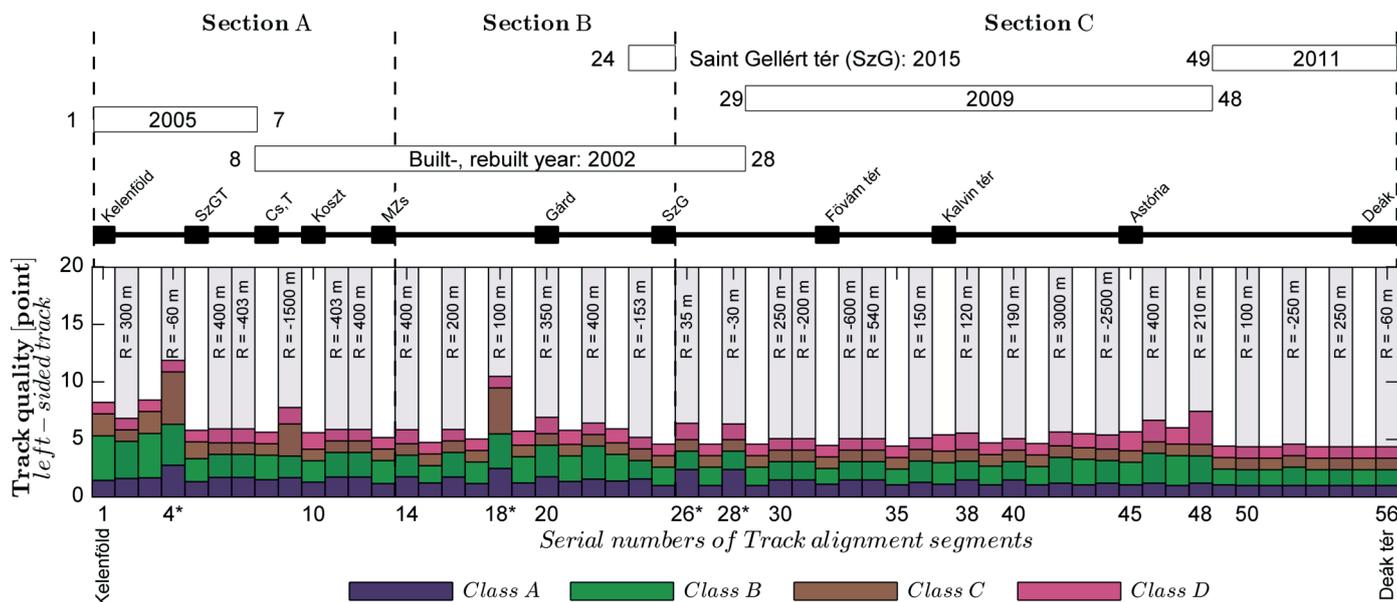
Fig. 2 At the top: built/last re-built year of track alignment segments; at the bottom: category-rated track quality (in points) computed per alignment segments of the left-sided track according to Subjective Track Condition Assessment Method (discription of classes in Table 1); \*significant rail sidewear on curve

Each geometrical track segment is assessed based on the developed criterion system, but only the weighted average category points is presented in Fig. 2. Minor differences are observed between the left and the right-sided track. Only those curved track segments have high score in deterioration rate, where significant rail wear is observed (See in Fig. 2: Segment 4\*, 18\*, 26\*, 28\*), or the track irregularities can also be seen in visually perceptible manner (See in Fig. 2: Segment 18\*, 48). The segments indexed between 49 and 56 are renovated couple years ago, so they show homogeneous condition. (After assessments carried out, the track section between M3ríc Zsigmond tér ('MZs') and Szabadság Bridge was renovated in summer 2016)

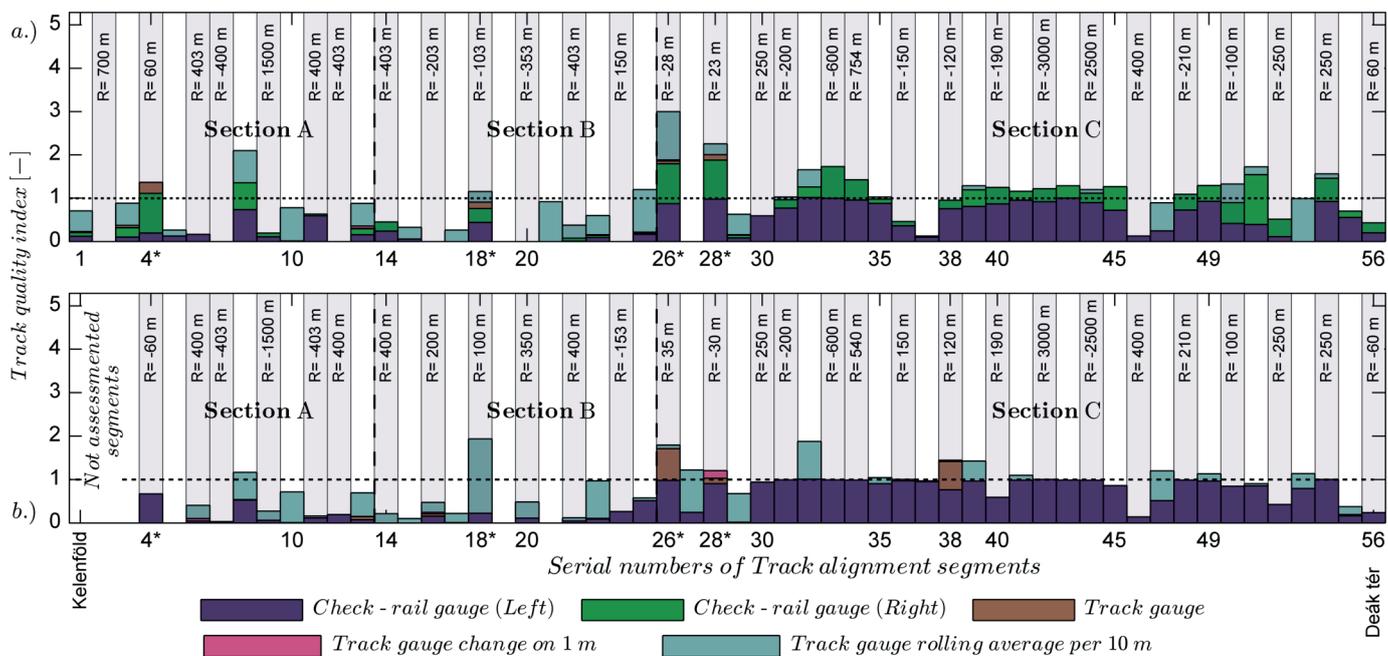
**Fig. 3** Computed track quality index of alignment segments according to the results of quasi-objective condition assessment (un-loaded track geometry measurement by TrackScan [14]): a.) on right-sided track, b.) on left-sided track; \* significant rail sidewear on curve

Among the curved track segments 4\*, 18\*, 26\*, 28\*, 38 have significant peaks in deterioration level. (Refer to section 4.1). On these segments significant rail vertical-, and side wearing,

as well as corrugation can be observed. It should be noted that the superstructure of the segment 26 and 28 are different from the others. On segment 4 in *Section A* the grooved rail head is in poor condition. It is broken and its considerable lengths is missing. This is demonstrated by the high value of check-rail gauge too. On segment 18 in *Section B* there was an accident before half year of measurements, where a tram carriage derailed. After accident this segment was renovated, but a significant alignment faults remained, which is clearly demonstrated by the high value of track gauge parameter index. The *section C* was rebuilt the latest, whose newest part is between Segment 49 and 56.

Considerable fault cannot be found on this part of *Section C*, but the measured rail-check gauge exceeds the admissible limits in significant length (more than 90% defects rate). The reason of this high rate is that track is built with 1% cross sectional gradient in straight section due to drainage, so significant vertical and side wear have been formed on the outer rail in each track. In segment 38 of left-sided track reduced track gauge is measured, which can be construction failure.

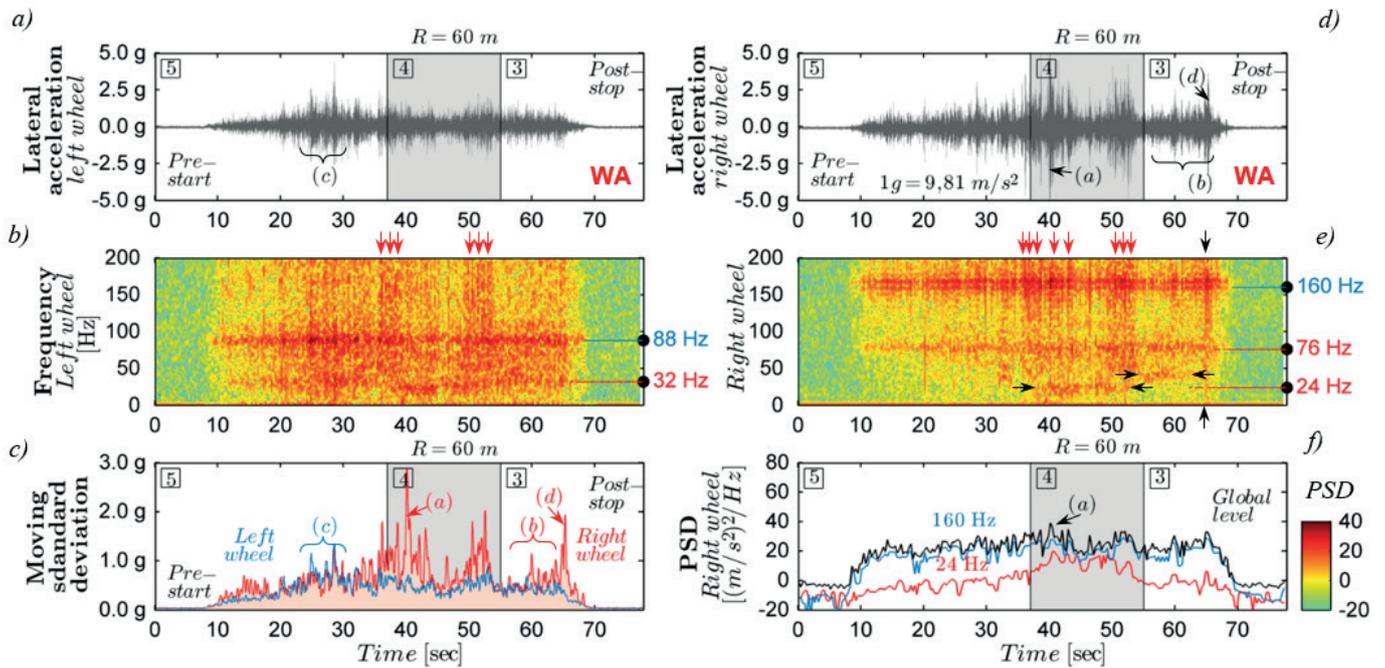
**Fig. 5** Analysis of the first wheelset lateral accelerations recorded on tram line 49 from segments 5 to 3; Acceleration time histories a.) left-, d.) right-sided wheel; STFT Spectrograms b.) left-, and e.) right-sided wheel; c.) Moving standard deviation of two time histories ; f.) PSD corresponding to right-sided wheel

The acceleration peaks identified on left and right side are analysed and compared. There is one right-sided curve (segment no. 4) within this investigated track section. The left-sided wheel corresponding to the inner rail, while the right-sided wheel to the outer rail. In this curve, the wheelset is oriented to outer rail and the wheel flange is in contact to the rail gauge side, which causes significant differences in moving standard deviations of the left-, and right-sided wheel in Fig. 5c. Furthermore, a significant outstanding value can be observed at the place of (a) on right rail at 40 s (See Fig. 5c. and Fig. 5d), which refers to a misalignment rail illustrated in Fig. 7.

In the straight section no. 3 the grooved head of right rail has significant side wear (See Fig. 8), which generate significant differences between measured lateral accelerations on both sides. (See (b) and (d) on Fig. 5c and Fig. 5d).

Track defect can also result in dominant frequencies, when they carry relatively high energy peak among all frequencies found in the spectrum. In the curve section the wheelset is oriented to outer rail and the wheel flange is in contact to the rail gauge side, which causes a broad band excitation on outer rail (see red arrows on Fig. 5b and Fig. 5e). This is reflected by the spectrogram red colors in column-wise.

An approximately 40 Hz excitation is observed on the straight alignment segment number 3, (see Fig. 5e between 55 and 63 s) which refers to the contact between the wheel flange back and a grooved rail-grooved head. This situation can be formed only on faulted track section (See Fig. 8).

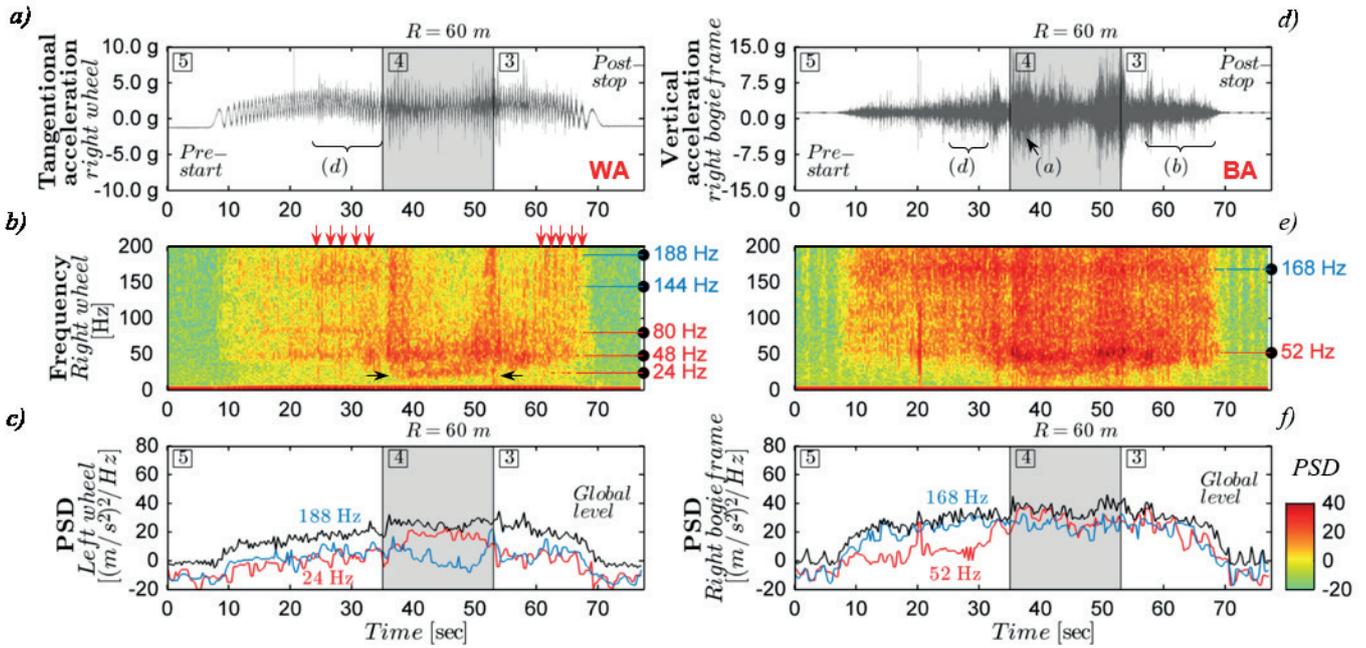
**Fig. 6** Comparing the accelerations recorded on first-right wheel and same side bogie side-frame on tram line 49 from segments 5 to 3; a.) wheel tangential acceleration, d.) bogie side-frame vertical acceleration; STFT Spectrograms corresponding to b.) wheel, and e.) bogie side-frame; PSD corresponding to c.) wheel, f.) bogie side-frame

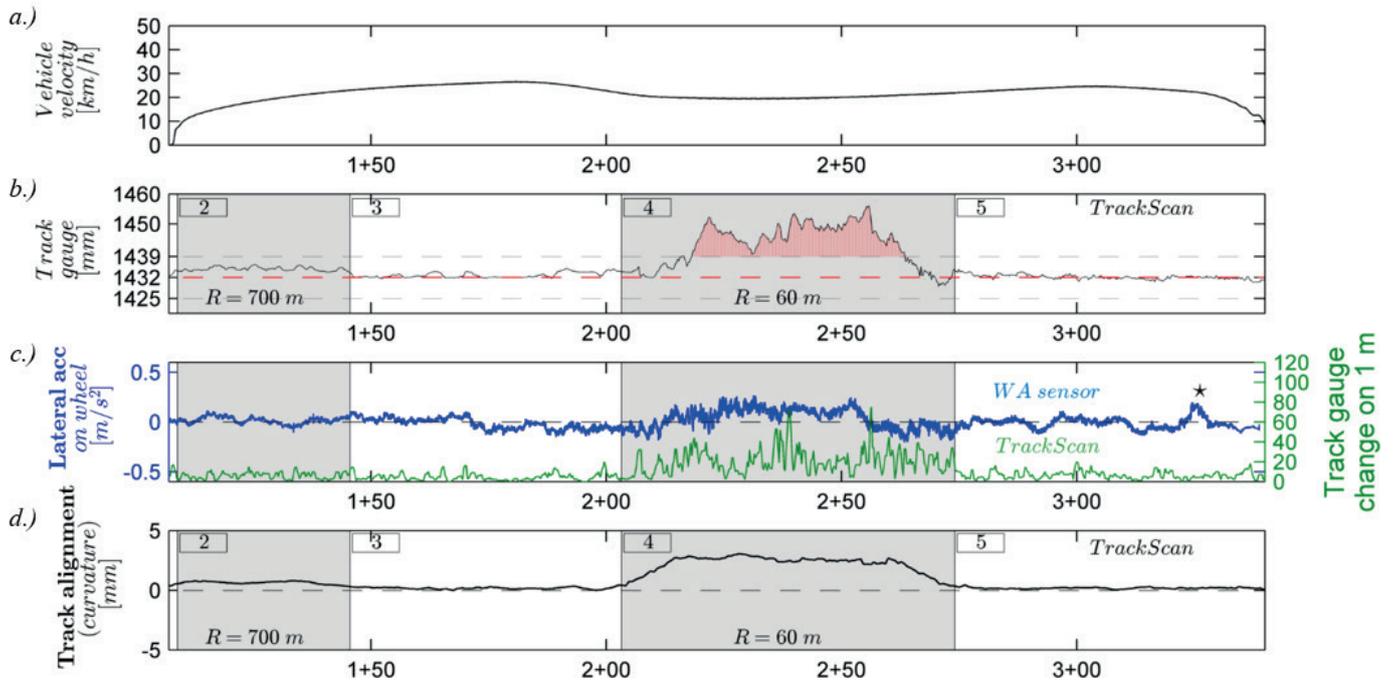
**Fig. 9** Comparison of measurement results under un-loaded and loaded condition between alignment segments 1 and 5 on right-sided track; a.) vehicle velocity computed from wheel tangential ( $a_x$ ) and radial acceleration ( $a_y$ ); b.) track gauge measured by TrackScan; c.) filtered lateral acceleration recorded on first-left wheel; c.) the measured track alignment by TrackScan. (x axis of each diagram presents the track chainage in hectometre).

The filtered lateral acceleration signal at the chainage between 3+20 and 3+30 has peak (\*signed the place in Fig. 9c), which is caused by a sinking sewer close to track.
