Effects of Structural Parameters on Seismic Behaviour of Historical Masonry Minaret

Abstract

Van Ulu Mosque, Van earthquakes, operational modal analysis, seismic performance, brick masonry

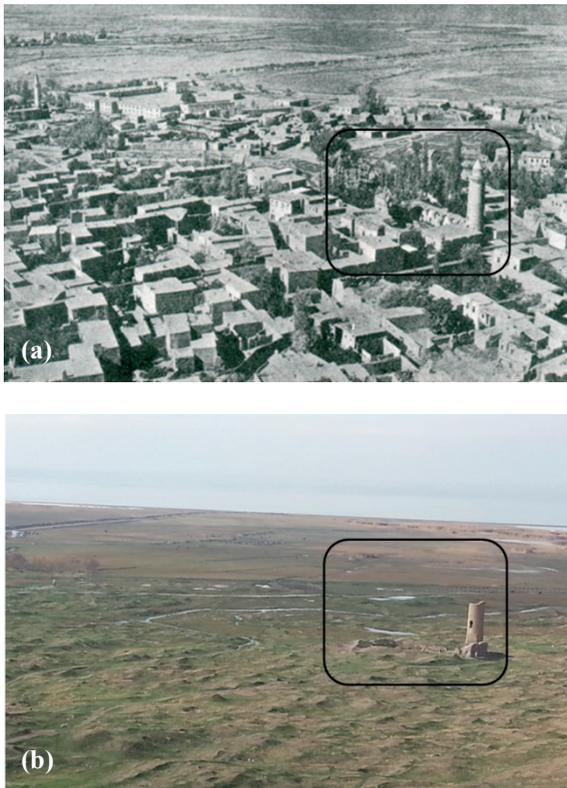
the core inside the cylindrical body. In Fig. 1.a, a balcony and the roof is clearly seen but neither of them survived today as shown Fig. 1.b. Since the minaret is located next to the mosque it has a connection with the west wall of the mosque.

Fig. 1 The change in Old Van City and Van Ulu Mosque in 100-year period
a) Old Van City and Van Ulu Mosque in 1913 [2], b) Old Van City and Van Ulu Mosque in 2013

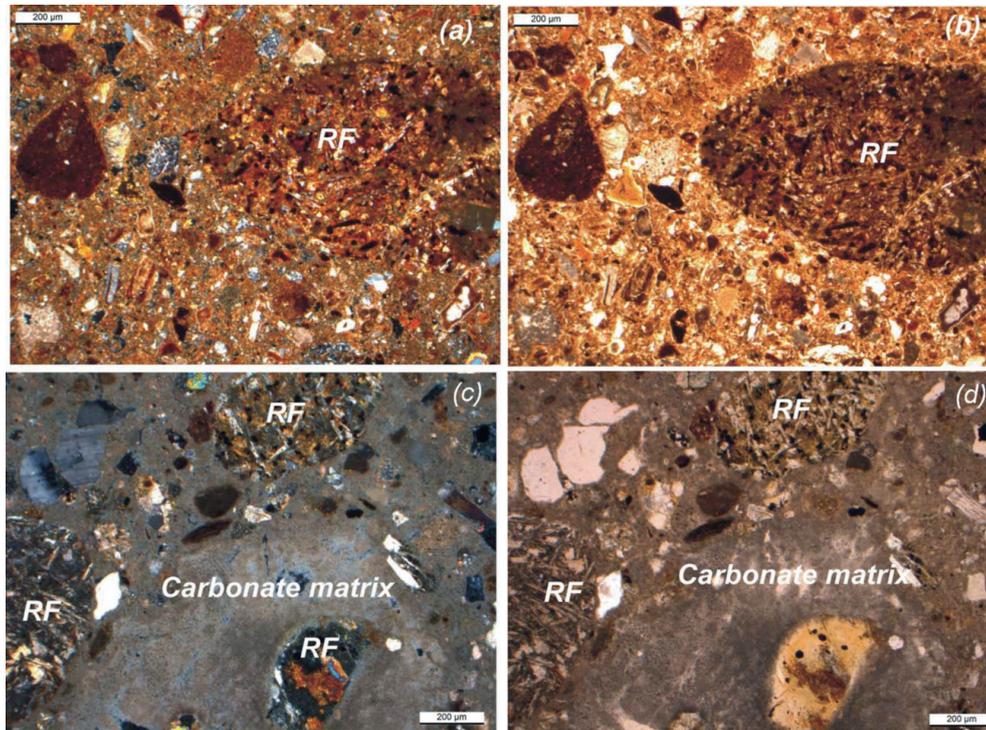
Fig. 3 Photomicrographs of the thin sections (scale 200 µm) a-b) Brick sample, c-d) Mortar sample

From the petrographic analysis of the brick samples, it was found that they have volcanic origin and the main material was ignimbrite which is common in the region. Brick samples are composed of rock particles, pumice stone, mineral crystals and volcanic glass (Fig. 3). The XRD results revealed that there are high concentrations of minerals of calcite, quartz, illite and feldspar. However, mortars have different compositions as compared to bricks and the matrix is found to consist of carbonates and is in highly heterogenic structure including volcanic, sedimentary, serpentinite, rock particles and minerals. Having different rock particles and minerals in a matrix made of carbonate indicates that the mortar is a mixture of river sand and limestone (Fig. 3). The XRD results verify that observation, since the mortar was found to be composed of densely populated gypsum and calcite and also less densely feldspar, clay and quartz are visible.

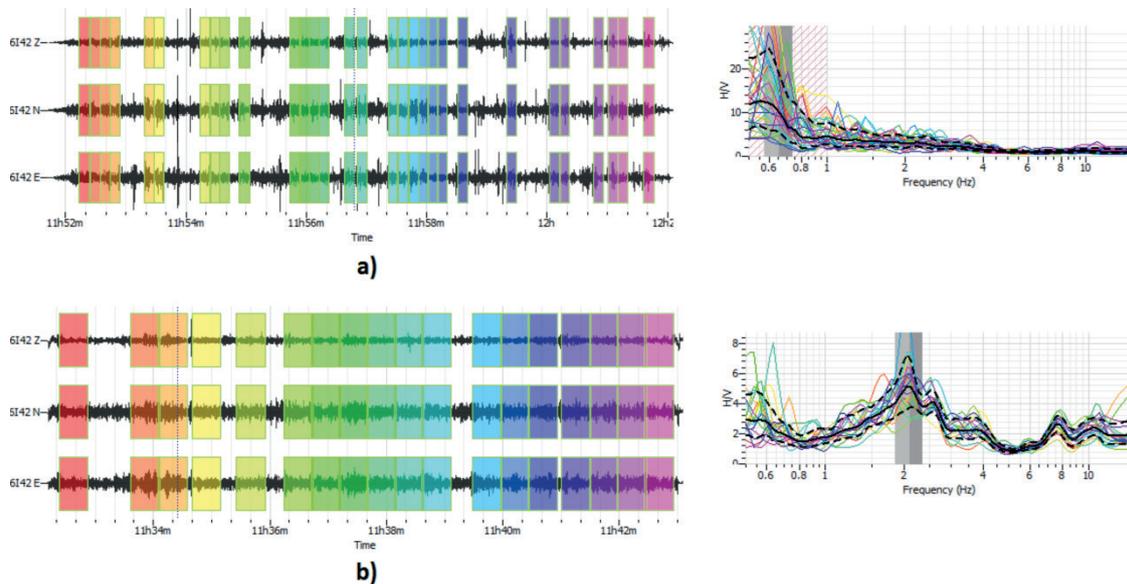
Fig. 7 Microtremor data and H/V spectra for the minaret of Van Ulu Mosque, a) Soil, b) Inside the minaret at 5.5 m above the ground level

Peaks around 0.6 Hz, 2 Hz, 3 Hz, 4 Hz and 8 Hz were observed from the H/V spectrums plotted from the microtremor recordings taken from the soil inside the mosque. The natural frequency of the soil is found to be 0.64 Hz and this information together with the general soil profile in the region as mentioned above reveals that the minaret was built on Z4 soil type as defined in Turkish Earthquake Resistant Code [15]. When evaluating the recordings taken from the inside of the minaret, it was realized that the natural frequency of the minaret is 2.08 Hz and its period is 0.48 s (Table 2). Since it is in highly vulnerable state no recordings were taken from the upper part of the minaret.

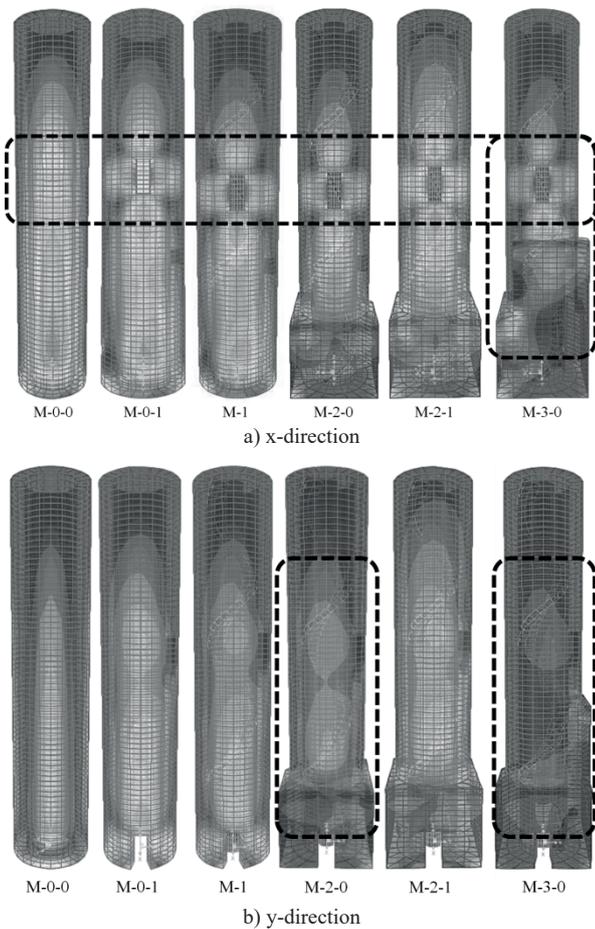
Shear stress distribution (SSD) in x and y directions under combined gravitational and earthquake loading is shown in Fig. 12. From the distribution in x-direction it is seen that, introducing window openings results in a localized shear stress around the opening in all models except M-0-0. The pulpit in M-2-0 and M-2-1 seems to relieve the stresses at the lower part of the minaret but shear stress at the top of the pulpit increased due to the sudden change in the cross-section. All the SSD are almost symmetric except M-3-0. Since the brace wall is introduced in this model, SSD changes significantly. A flow from the pulpit to the brace wall up to the window opening is visible. SSD is found to follow the staircases and stresses started to accumulate the points where the cross-section changes significantly. As for the y-direction, it is seen that for the cylindrical body in M-0-0, shear stress distribution changes gradually from top to the bottom and it is symmetric around x-axis. However, with the

introduction of openings in M-0-1 there exist two separate distributions around each opening. Staircase and the core slightly affect the distribution but pulpit reduces the stress in the lower part significantly. A slight unsymmetrical distribution can be seen in M-2-0 since it has a chamfered pulpit. When the chamfer is ignored the distribution again turns out to be almost symmetrical. A more pronounced and unsymmetrical distribution is seen from M-3-0. It is observed that shear stresses concentrate above the window at east facade and at the connection between pulpit and the brace wall. SSD in x-direction for M-3-0 reveals that diagonal cracks from the window to the pulpit and from the window to the above are highly possible. As a conclusion, SSD in M-3-0 is found to be consistent with the cracks on the minaret shown in Fig. 4 and it can be said that brace wall may be the cause for the diagonal cracks.

Fig. 12 Shear stress distribution under combined gravitational and earthquake loading

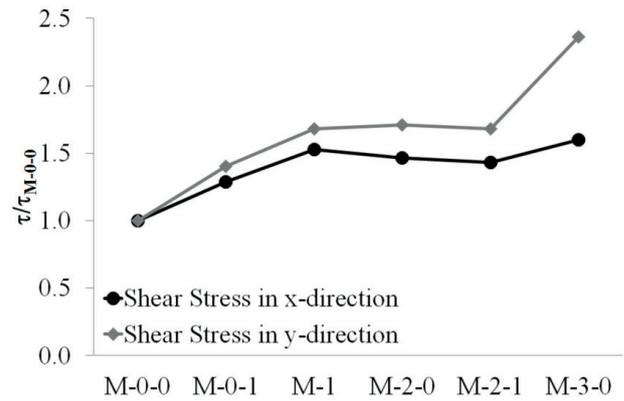
Fig. 13 depicts the change in maximum shear stress developed in each model. It is seen from the figure that maximum shear stress increases from M-0-0 to M-3-0 indicating that each change in the model influence the shear stress. Maximum shear stress increases with openings, staircase and the core but reduces with the pulpits. However, it increases dramatically with the brace wall. Change in maximum shear stress in y-direction is more pronounced indicating that shear cracks are more likely to develop in this direction. Therefore, it can be said that brace

wall, opening, staircase and the core may be responsible for the diagonal shear cracks since they increase the maximum shear stress but pulpits relieve the stresses slightly.

Fig. 13 Change in maximum shear stress
