Ylber Muceku^{1*}, Olgert Jaupaj²

TECHNICAL NOTES

Abstract

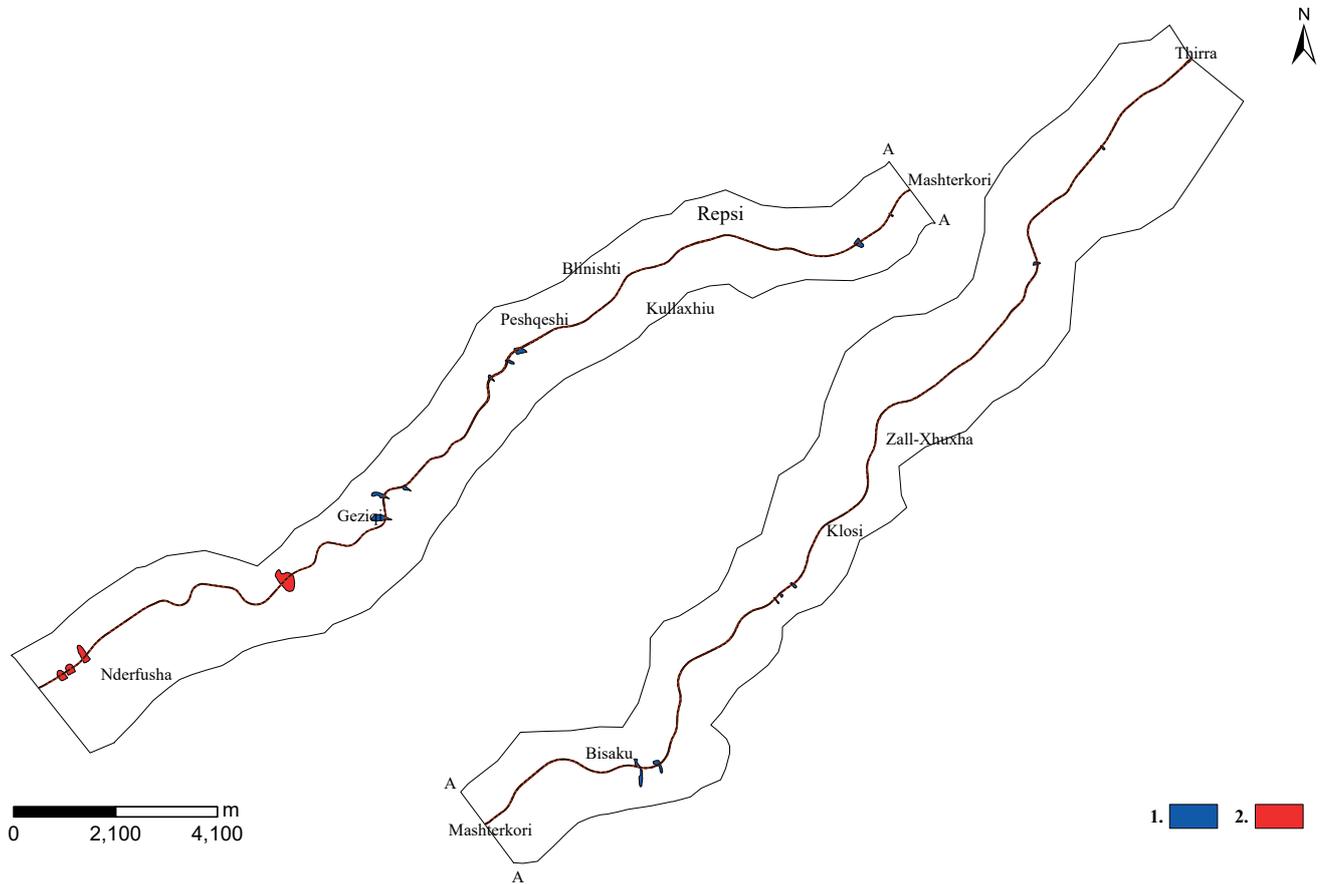
The four-lane motorway crosses the north-eastern Albania from Miloti in the northwest to the city of Kukës, in the east, traversing the Mirdita-Kukesi mountain range. There is a great variety of lithological types and geotechnical conditions, as well as various features in term of weak rock mass and potential for unstable slopes. In the case of geo-engineering studies [15], since the early stage of design, the motorway area has been subject to landslide occurrences. The first data were taken from geo-engineering studies [15], in 2004–2006, before and during the motorway construction. There have been identified 15 debris flows on the slope hills built by basalts, plagiogranites and gabbros, as well as 5 earth slides on the molassic formations (Figs. 2, 3).

Fig. 3 Landslides map of studied area
1. Debris flow, 2. earth slide

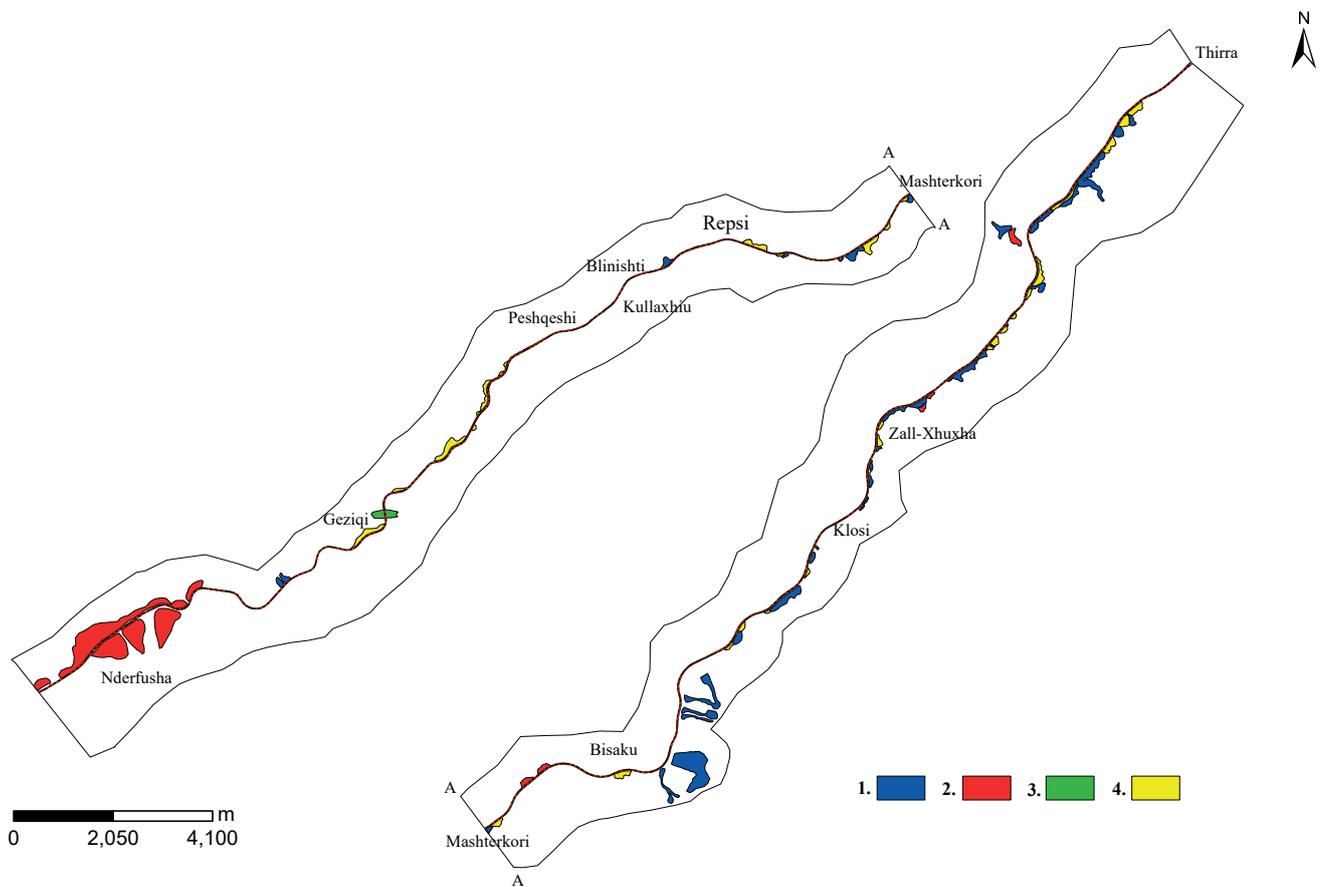
Fig. 4 Landslides map of studied area
Debris flow, 2. earth slide, 3. rock slide, 4. rock fall

3 times per year, causing serious problems in this region. The maximum rainfall was recorded on October 1970 (180.5 mm in 24h) and on January 1963 (189.6 mm in 24h) [17]. Over the years, mass movements have been occurred and others are also to be expected in the future, suddenly and in large quantities (Fig. 4). They are classified in rocks fall, debris flow, earth slides and rocks slide [4].

From the geotechnical analyses carried out on this area, 49 earth slides have been mapped (Fig. 4) [16]. They are located to the north of Rresheni town, Ndërfusha, Mashtekori-Bisaku and ZallXhuxha villages (Fig. 4). The landslides body consists of inorganic silts and very fine sands [1] (Figs. 8, 9).

The rock slides on the studied area has occurred on hills slopes-cut slopes which are built by ultrabasic rocks along the segment 36.44–36.58 km of the motorway (Fig. 4). The ultrabasic rocks in this site are intensively fractured and weathered. They are separated from joints in blocks with different sizes. Due to man-made works (blasts) during the road construction, on the slopes cutting, a large fault on ultrabasic rocks was observed. It lies from top to bottom of the slope with a dip angle of 55° – 68° , almost parallel to the hill slope and below the motorway. In this situation, the slope stability was in a critical condition because a large ultrabasic mass in unstable state threatening the motorway's stability. It is 350.0 m long, 140.0 m wide and the failure's plane lies from 15.0–20.0 m up to 35.0–40.0 m in depth.
