Assessments of Masonry Buildings and Historical Structures during the 2020 Sivrice-Elazığ Earthquake

Alper Özmen^{1*}, Müslüm Murat Maraş¹, Yaşar Ayaz¹, Erkut Sayın²

2020 Sivrice earthquake, seismic performance, masonry buildings, structural damages, field investigation

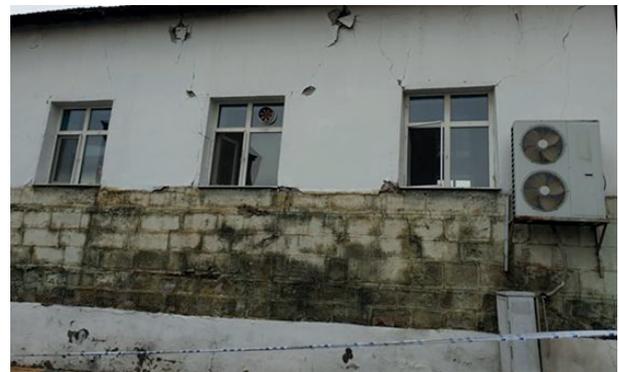
In-plane mechanism was observed in most of these buildings that are affected by shear cracking in the earthquake area. Figs. 9 and 10 show in-plane wall failure (diagonal cracking) due to the in-plane load. In the area struck by the Elazığ-Sivrice earthquake, most of the masonry buildings did not have sufficient and proper bond beams to enhance the lateral strength of the walls. The stiffness

of the walls has been decreased by large openings on the walls. Also, these openings increased the shear effects. The requirements of the solid walls and openings of load-bearing walls are presented in Fig. 11 [10]. Turkish Seismic Code (TSC) requires the reinforced concrete bond beams to limit this type of failure. Fig. 12 illustrates vertical bond beam which increase the earthquake performance of masonry buildings. Also, Figs. 13(a) and (b) show the horizontal bond beam at the intersection and at the corner of the walls, respectively [9]. A horizontal bond beam above the wall can provide an effective mechanism to transfer the

Fig. 10 Diagonal cracking in masonry buildings

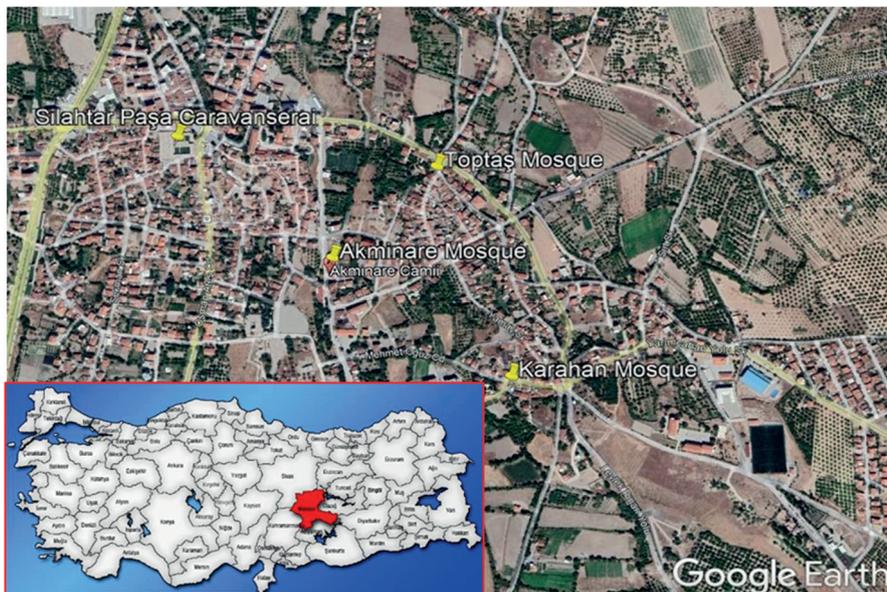
Fig. 26 Historical structures in Battalgazi town of Malatya

These historical structures had no damage. Karahan and Toptaş mosques are the oldest mosques in the region (Fig. 27(a)–(b)). Karahan and Toptaş mosques were built in 1582 and 1588, respectively. Also, these mosques do not have a dome. Akminare mosque was constructed in 1792 (Fig. 27(c)). Horizontal tie beams were used in these mosques. Openings which increased the shear effects during the earthquake were not close to the corner and each other and these openings were not large.

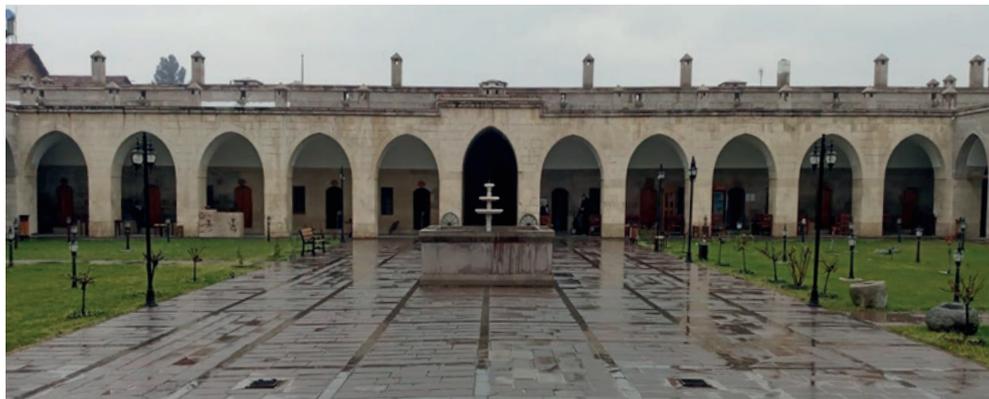
Also, some thin cracks with limited length were observed at the Silahtar Paşa Caravanserai after the earthquake (Fig. 28). The Silahtar Paşa Caravanserai located in Battalgazi was constructed in 1637 (Fig. 29).

Fig. 29 General view of the Silahtar Paşa Caravanserai
