Failure Mechanism of the Toppling Rock Slope with Different Numbers of Free Faces Caused by Excavation: a Case Study in Jiacha Hydropower Station (China)

Shao-Ping Huang^{1,2}, Kai-Ming Cao^{1,2}, Chang Zhou³, Heng-Lin Xiao^{1,2}, E-Chuan Yan^{4*}, Lu Cong⁵

Received: 18 June 2024, Accepted: 07 August 2024, Published online: 30 August 2024

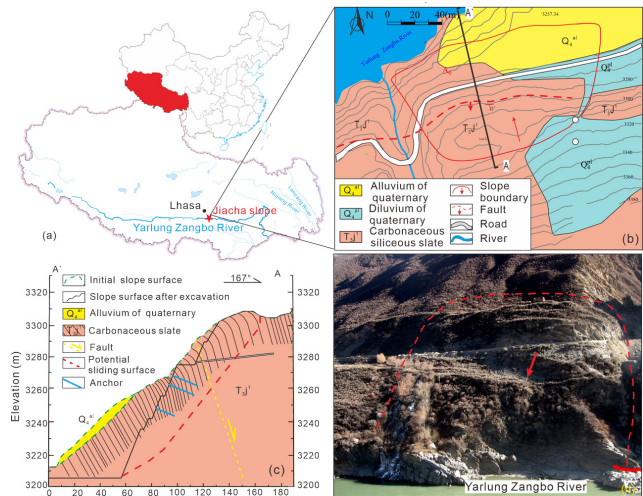
The Jiacha hydropower station is located on the Yarlung Zangbo River, in Xizang Province, China (Fig. 1(a)). It is located in the eastern part of the globally renowned latitudinal tectonic zone, namely the Tethys Orogenic Belt. It belongs to the primary structure. The Yarlung Tsangpo Fault Zone, a first-order structural feature, diagonally crosses the Yarlung Tsangpo River approximately 3 km downstream of the dam site. It generally follows the course of the Yarlung Tsangpo River, trending nearly east-west, with a steep inclination towards the south or north, forming a slightly southward convex arc, spanning over 1000 kilometers. This fault zone represents a massive tectonic boundary in the southern part of the Qinghai-Tibet Plateau, resulting from the tectonic evolution of the Indian Plate subduction and collision with the Eurasian continent. Along this fault zone, there are development of Cretaceous ophiolite suites, mixed rock zones, and Mesozoic-Cenozoic mafic and ultramafic intrusive rocks. Furthermore, it controls the distribution of early Mesozoic acidic and alkaline intrusive rocks as well as lava eruptions on the northern side. Since the Himalaya movement, the whole Yarlung Zangbo River has been involved

The study area is described as an unstable mountainside, which is above 700 m high. It is situated on the left bank of the Yarlung Zangbo River and is far away from the hydro-power station about 230 m. It is distributed at elevations ranging from 3200 m to 3310 m, with a height of about 110 m. The planar shape of the slope is trapezoidal (Fig. 1(b)), and its' slope gradient is from 35° to 40° (Fig. 1(c)). The overall terrain shows that it is lower in northern regions than that in southern regions. The lithology of the slope rock mass is mainly composed of the interbedded structure of thin-medium thick layer rock mass, which is mainly carbonaceous slate with sericite quartz schist (T_{3j}^1). A fault belt (EW/S70°) with a length of about 630 m is developed in the upper part of the rock slope, and the width of the fault fracture zone is about 1 m–3 m. In addition, three sets of major control structural planes have been identified through field investigations: 1) the occurrence of the first dominant joint surface is EW/S50°–70° which intersects with bank slope at a small angle; 2) the second one is SN/W80°–85° with a space of 0.1–0.3 m, which is perpendicular the strata; 3) the third one is N50°60'W/NE40°–45° with a space of 0.3–1.0 m and intersects with the bank slope at a small angle. The slope was excavated with aims to create the diversion canal (Fig. 1(d)), resulting in the formation of many unloading cracks. The loosened fractured zone extends to a depth of about 1 m at the road.

Fig. 1 a) The Location of the Jiacha slope; b) Topographic and structural outline map; c) Cross-section profile of the slope; d) Panoramic view of Jiacha slope before excavation

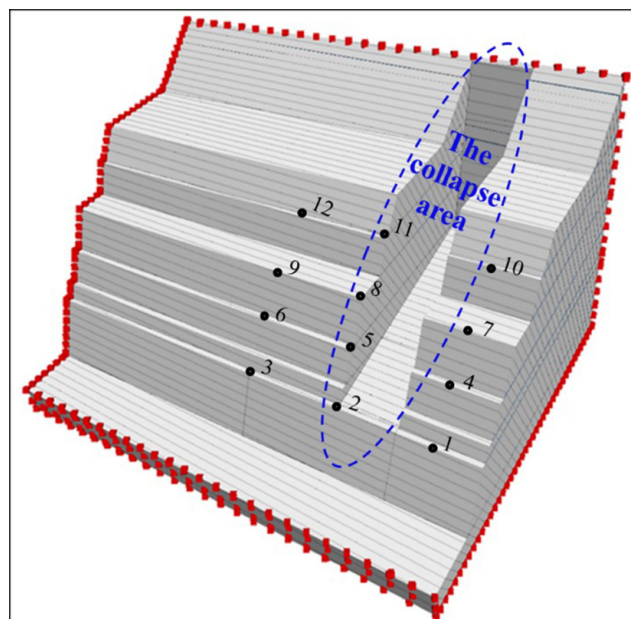
The lithology of the geological model was set as sandstone and slate. The rock thickness was set to 10 m (average rock thickness). This model range of the Z-axis, Y-axis, and X-axis was 0–150 m, 0–270 m, and 0–210 m, respectively.

Fig. 10 A simplified model for numerical simulation

In order to systematically and deeply study the number of free faces as a key factor affecting the deformation characteristics of toppling rock slope, 12 monitoring points were set up on the model (Fig. 10). The displacement of these monitoring points under different analysis steps and in different directions as illustrated in Fig. 12. And it can be clearly observed that all of the curves in

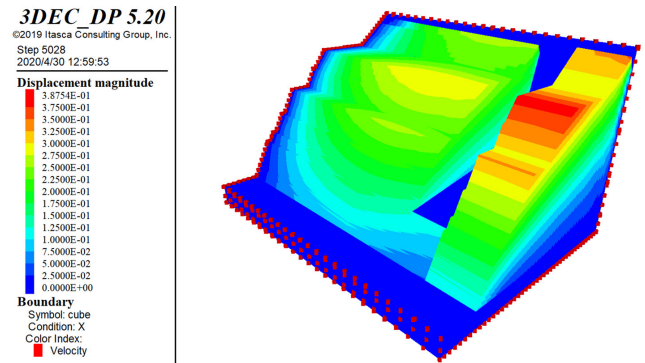
The influence of the numbers of free faces on the displacement was revealed by 3DEC. From the results of the simulation, it is clear that the slope with three free faces has the largest deformation, the displacement contour shown in Fig. 11. From the results presented above, it is well recognized that the numbers of free faces caused by excavation has a significant impact on the stability of slopes. Furthermore, the slope with a free face primarily undergoes a "U" shaped outward bulging deformation in the middle of the free face. In addition, it is also clear that 'Book-style' bending toppling occurs on the slope with two free faces, its displacement decreased from the slope surface to the inside and from upslope to downslope, and the slipping surface is fan-shaped. At the same time, it can be also observed that the deformation of the slope with three free faces decreased from the slope surface to the inside and the shape of the sliding surface is linear, this will further evolve into a linear fracture and the overall failure will occur. The numerical simulation results presented above reveal that more free faces could increase the probability of slope instability, and thus it should be emphasized that the excavation of multiple free faces should be avoided in the process of engineering construction as much as possible and the preventive engineering measures should be performed on the slope in time.

Fig. 11 Displacement cloud map of numerical simulation

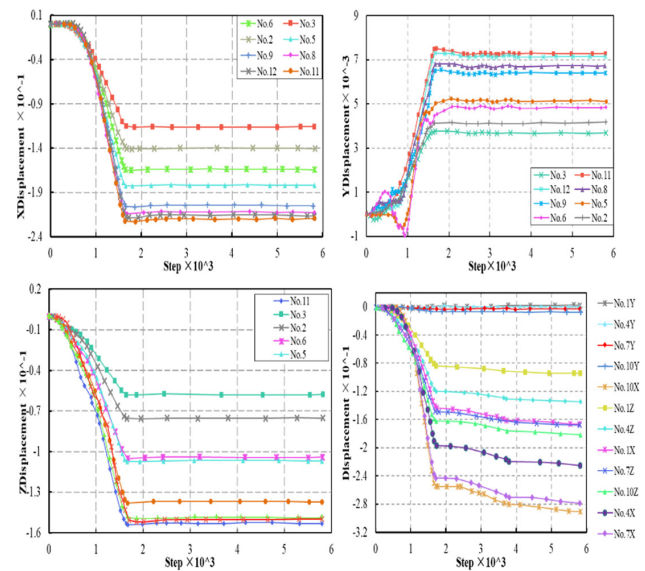
the same direction show similar trends. In the left two parts of Fig. 13, the displacements of the two free faces slope in the X and Z-direction firstly increase slowly, rapidly increase after 500 steps, and then tend to be stable at 1700 steps. The deformation gradually decreases from top to bottom, and gradually decreases in the slope from the surface near the open space, which is consistent with the field monitoring data. The displacement generated in the X direction is the largest, and the bending deformation is the most obvious. The typical characteristic of the toppling rock slope is that the deformation in the Y direction is the weakest. This is due to the fact that the rock

Fig. 12 Monitoring displacement curves of numerical simulation

layer and the side surface are nearly perpendicular, resulting in insignificant deformation in this direction. The Y-direction deformation of the three free faces slope is the smallest, the X-direction deformation is obvious, and the displacement in each direction gradually decreases from top to bottom.

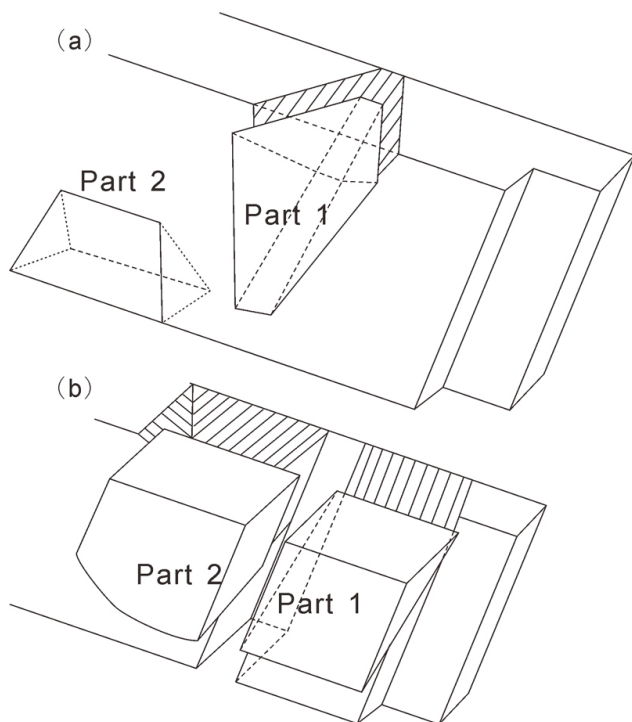
Single free face rock mass slope is mainly controlled by the dominant joints set and wedge sliding occurred in this slope (Fig. 13(a): Part 1). Moreover, this slope was also influenced by the unloading effect, so the prismatic sliding occurred in the slope toe (Fig. 4). In the double free faces rock mass slope, the combination of the free face and joint set controls the failure model of the toppling rock mass slope [33]. This failure mode can be summarized as unloading and rebounding – dumping and breaking – bulging – shearing – overall failure. In this paper, three dominant joints cut the strata and wedge sliding along the intersection line of two discontinuities occurred [34] (Fig. 13(b): Part 2). However, after the upstream potential collapse area (B area) is affected by the collapse area and forms a three-face void, the rock slope with three free faces could first bend and then slides along a discontinuity under the action of its own weight and unloading (Fig. 13(a): Part 1) [26–27, 41].

Fig. 13 Sliding and toppling failure model for rock mass slope with (a) one free face; (b) double, and three free faces

A single free-face slope, constrained by both sides and the base, primarily undergoes deformation controlled by joints. Under the influence of gravity and unloading, deformation tends to concentrate in the middle of the free face, presenting a bulging phenomenon in the center. Typically, the deformation is minor, resulting in 'wedge-shaped body' failure (Fig. 13(a)), and primarily develops disasters such as collapses. After such slopes are predisposed to disaster, the continuous fracturing and collapsing of the rock mass provide a free face for the remaining rock body.
