# REASONING ABOUT THE DAMAGE IN THE CENTRAL BUILDING OF THE TECHNICAL UNIVERSITY OF BUDAPEST

Ernő Biczók<sup>1</sup>

## Abstract

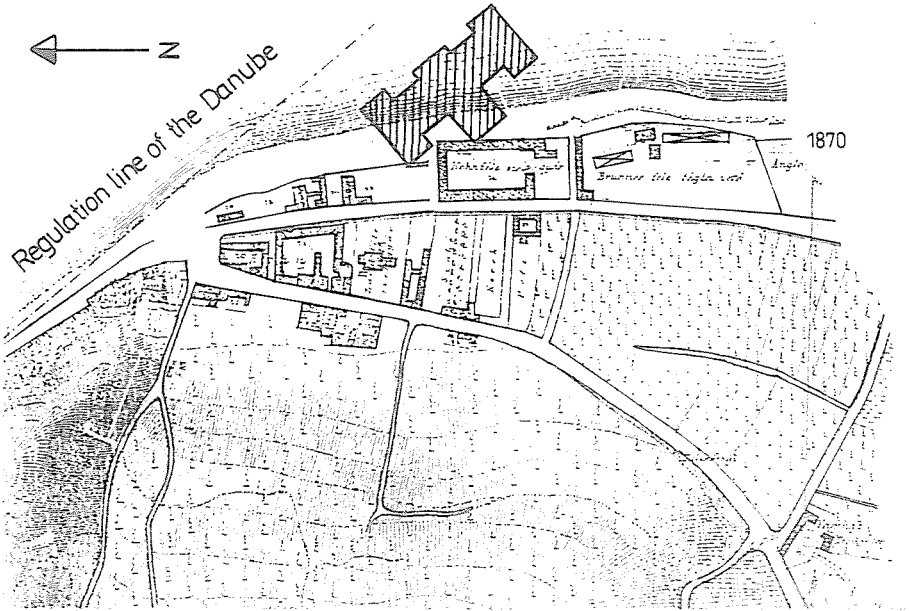
The more than 200 years old Technical University of Budapest was settled to its present location at the beginning of this century. The place, once a flooded area of the Danube, had been regained by help of a regulating dam at the end of the previous century and then refilled with debris, wasted building and earth materials that were removed from the building sites of the capital city. So was built the Central Building of the University from 1906 to 1909 with a part of it lying on an ancient branch of the Danube (*Fig. 1*).

Fig. 1. Ancient map of 1870 with layout of the building

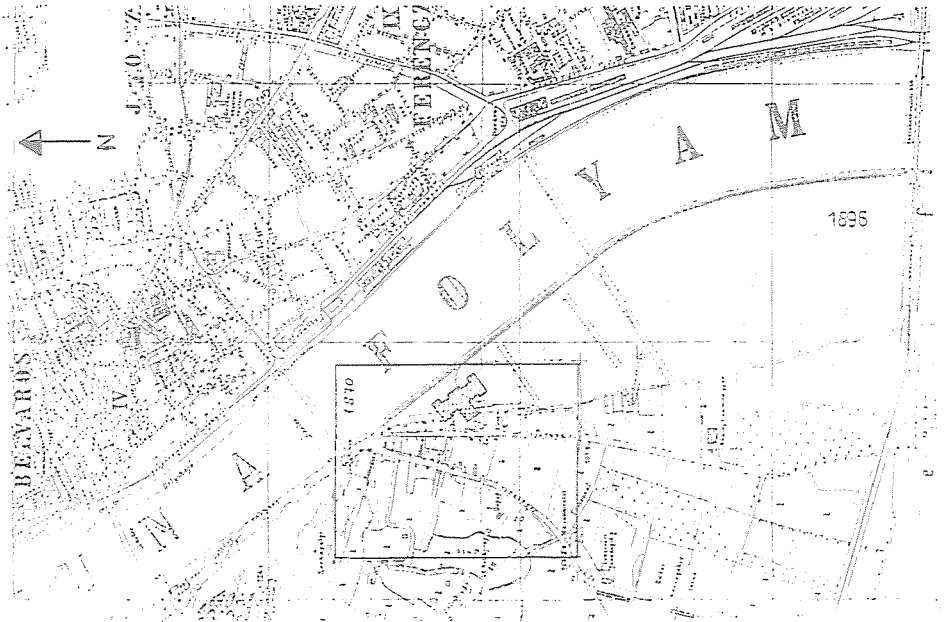
*Fig. 2* shows the refilled land at a later stage of construction works.

Fig. 2. An ancient map of 1896 with layout of the building
