THE DAMAGE OF THE TALL BUILDING AT PÉCS

Á. OROSZ

Department of Reinforced Concrete Structures
Technical University of Budapest

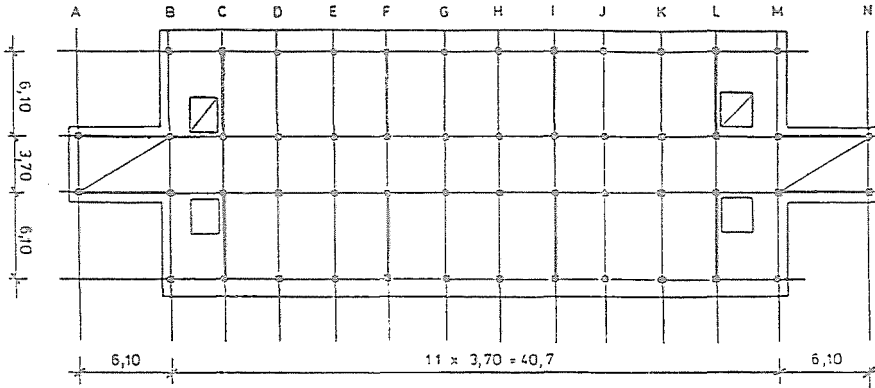
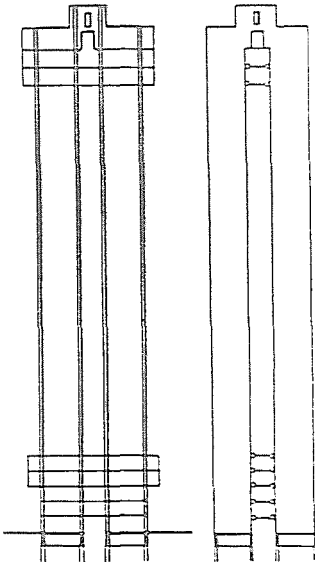
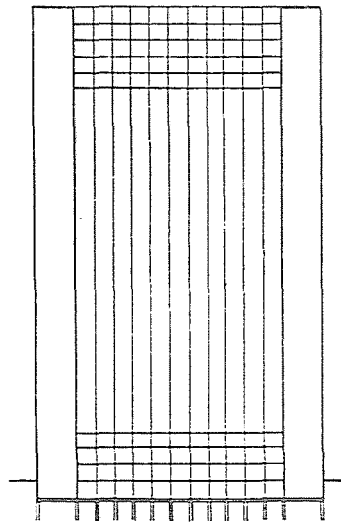
Fig. 2. The places of the wire corrosion and the ungrouted sections
 a.) section, b.) ground plan,
 1. cast in situ concrete, 2. prestressed wire,
 3. joining mortar (PU), 4. ungrouted sections,
 5. corroded tendons
