## FATIGUE TESTS ON THE OLD STRINGERS OF THE RAILWAY BRIDGES

A. SZITTNER, L. KRISTÓF and L. KALTENBACH

Department of Steel Structures,  
Technical University, H-1521 Budapest

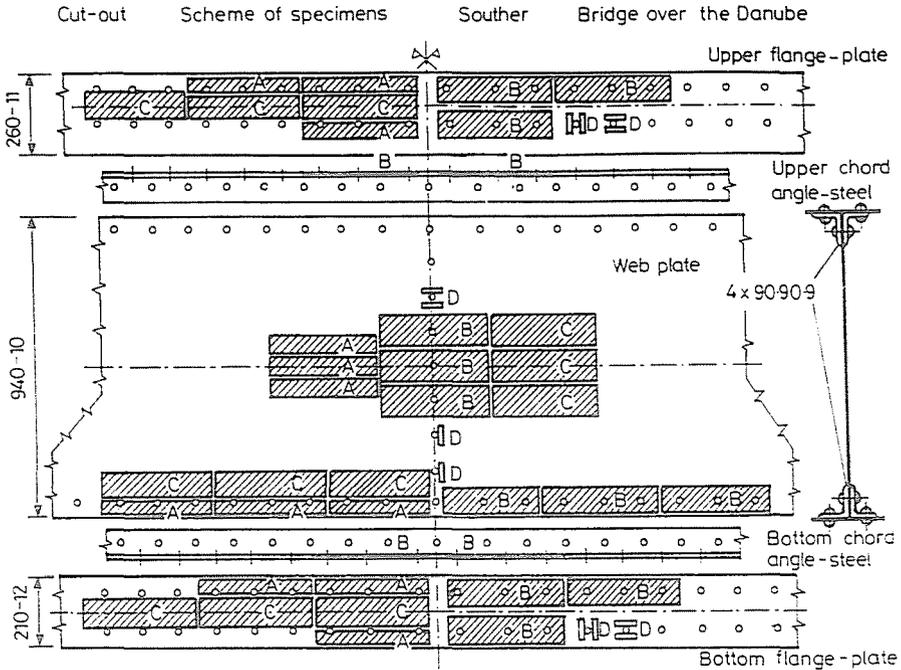
Fig. 1. Southern Railway Bridge. Cut-out plans of specimens

On the basis of the tensile tests of the Southern Railway Bridge, the steel material is satisfactory with respect to the tensile strength, yield point and ultimate strain. However, a very unfavourable result was yielded for the specific impact value, for which a minimal value of 27 Joule is stipulated in Standard MSZ 6280 in the case of a material of grade 37 at the temperature 0 °C. Particularly, all the test pieces of lateral direction without exception, while from among the specimens of longitudinal direction the ones positioned on the upper flange plate remain under the stipulated

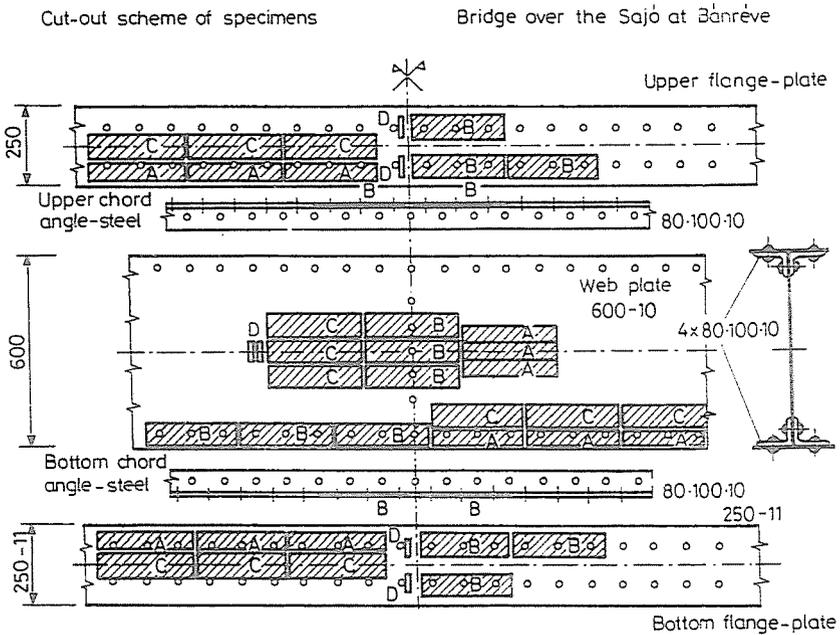
Fig. 2. Bridge over the River Sajó at Bánréve. Cut-out plans of specimens
