EXAMINATIONS FOR THE DETERMINATION OF LOAD-CARRYING CAPACITY OF THE BRIDGE OVER THE SEBES-KÖRÖS AT VÉSZTŐ

GY. SZABÓ

Department of Steel Structures
Technical University, H-1521 Budapest

Abstract

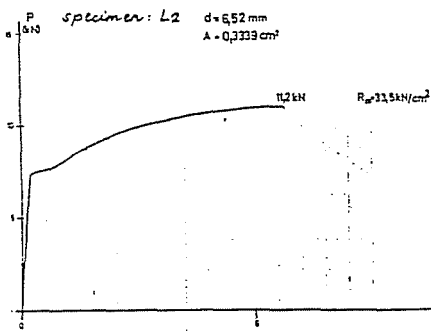
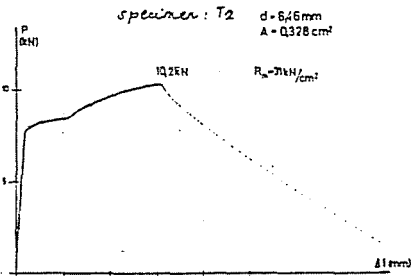
Fig. 4a.

The registration can be seen in *Fig. 4*, while the results are shown in *Table 2*. The values recorded with the use of two types of specimen and the machine shows a satisfying agreement between the data obtained.

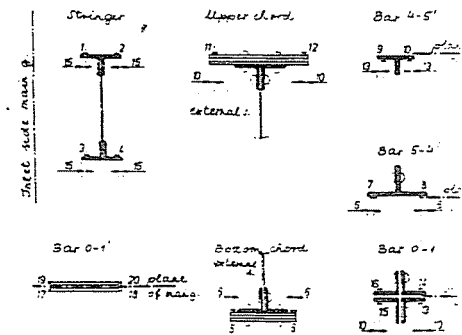
Fig. 12.

Strain-gauges were fixed at the points of the bridge as seen in *Fig. 12*, which were apt to measure the strains occurred, and to determine the magnitude of stresses subsequently.

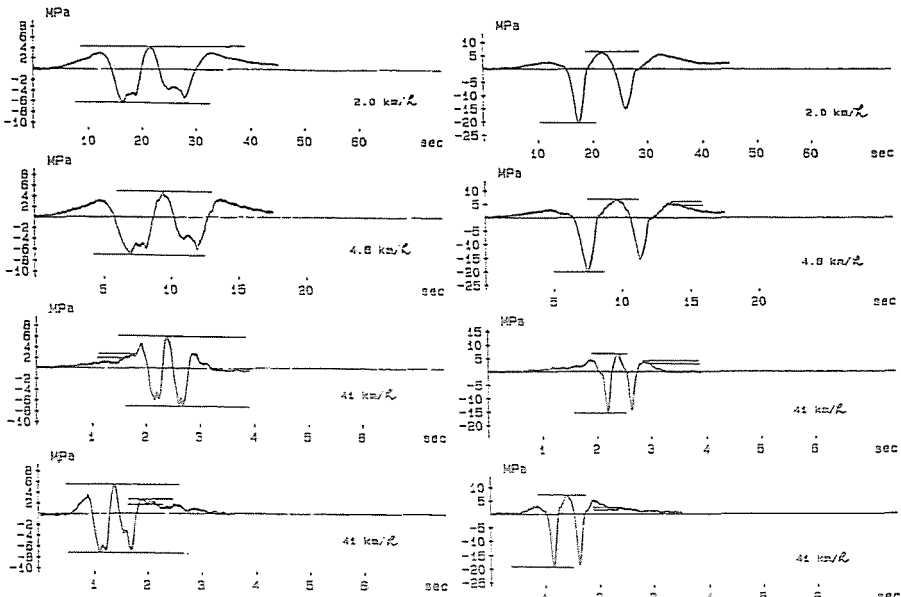
VG.11 Stringer gauge N#1 Load: A 124

VG.12 Stringer gauge N#2 Load: A 124

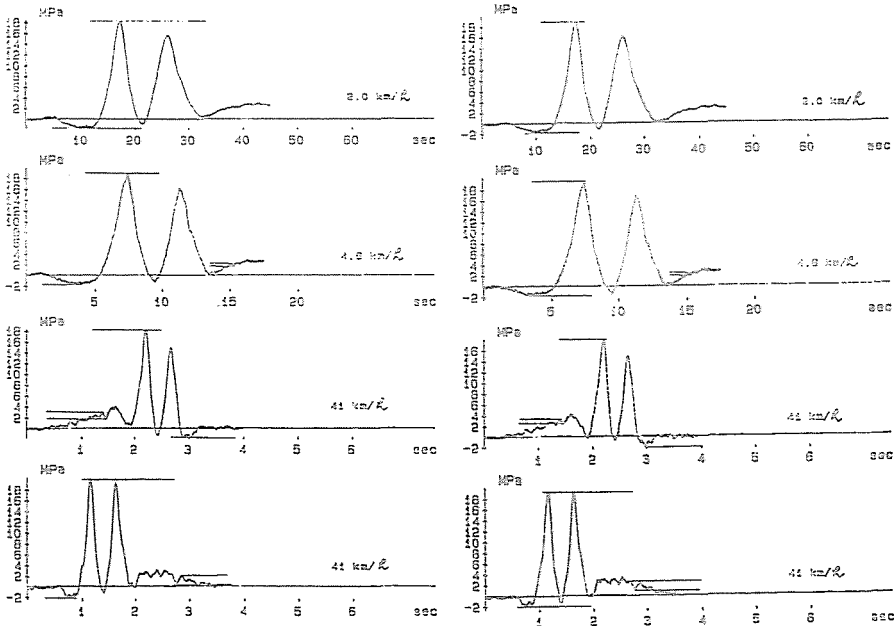
Fig. 13.

VG.13 Stringer gauge N#3 Load: A 124

VG.14 Stringer gauge N#4 Load: A 124
