# ANALYSIS OF THE FALL-DOWN OF THE BRIDGE OVER THE HERNÁD AT GESZTELY

P. PLATTHY

Department of Steel Structures  
Technical University, H-1521 Budapest

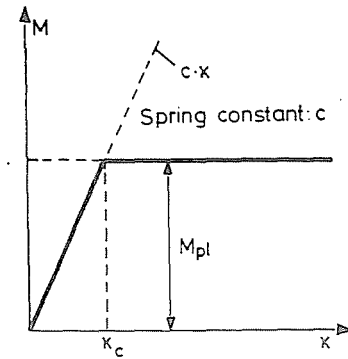
Fig. 9.

spring below it. The characteristic curve is shown in *Fig. 9* (it corresponds to the characteristic curve of an ideally elastic-plastic material model used commonly with the dimensioning of steel structures). If a horizontal force of magnitude ' $F$ ' is acting on the top of the column and the spring resistance is sufficiently great, then the column rotated by angle  $\kappa$  will be restored into its state of equilibrium. In such a case — with every data assumed as known except of force ' $F$ ' — the value of force ' $F$ ' can be re-calculated by means of angle  $\kappa$  representing the motion of the column (the problem is unmistakable). If subsequently force ' $F$ ' is increased gradually on, then at a critical force ' $F_{cr}$ ' and a hinge moment  $M_{pl}$  and angle  $\kappa_{cr}$  belonging to it, the column will be getting into motion (becomes unstable), and 'falls down' horizontally ( $\kappa = 90^\circ$ ). Of course, similarly a rotation by  $\kappa = 90^\circ$  will be the final result with each force:

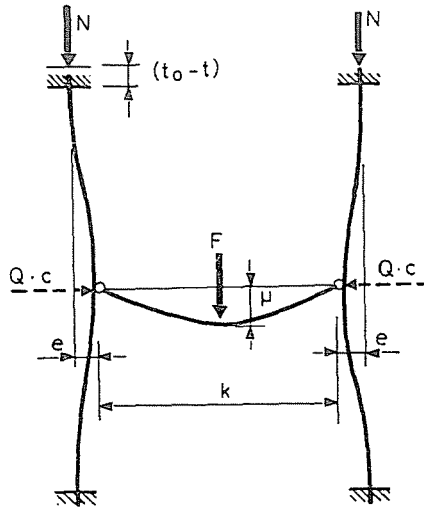
The impact bringing about the collapse can be examined by the model shown in Fig. 10. Since this model disregards the development of plastic hinge (the joints of the trussed girders of vertical plane are assumed to be hinged ones — as it is accepted in the practice of statics), the results approximate the reality from below. Due to it, it is reasonable to take into account an increasing factor of 1.5 with the minimum speed yielded.
