GEOTECHNICAL ANALYSIS OF AN EMBANKMENT BASE FAILURE

I. KABAI

Department of Geotechnique, Technical University, Budapest

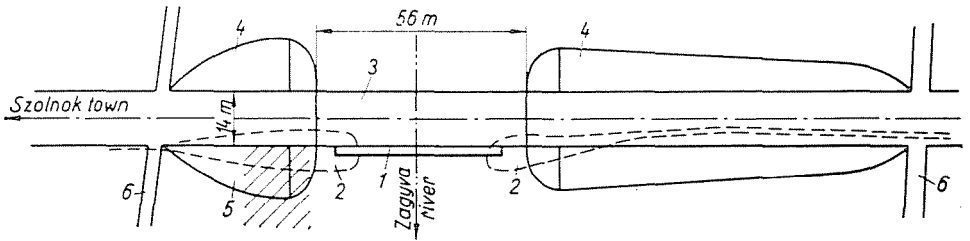
The new road and the 56 m long, reinforced concrete bridge over the river were inaugurated in 1958. Conditions before and after construction are shown in *Fig. 1*.

Fig. 1. Lay-out sketch: 1 — wooden bridge; 2 — old embankment to the wooden bridge; 3 — reinforced concrete bridge; 4 — embankment sections joining the reinforced concrete bridge; 5 — spot of base failures in 1975 and 1977; 6 — levee-dam of the Zagyva river
