## STABILITY OF THE ELEVATED RIVER BANK AT RÁCALMÁS

József FARKAS, Zoltán CZAP and Tamás VARSÁNYI

### Abstract

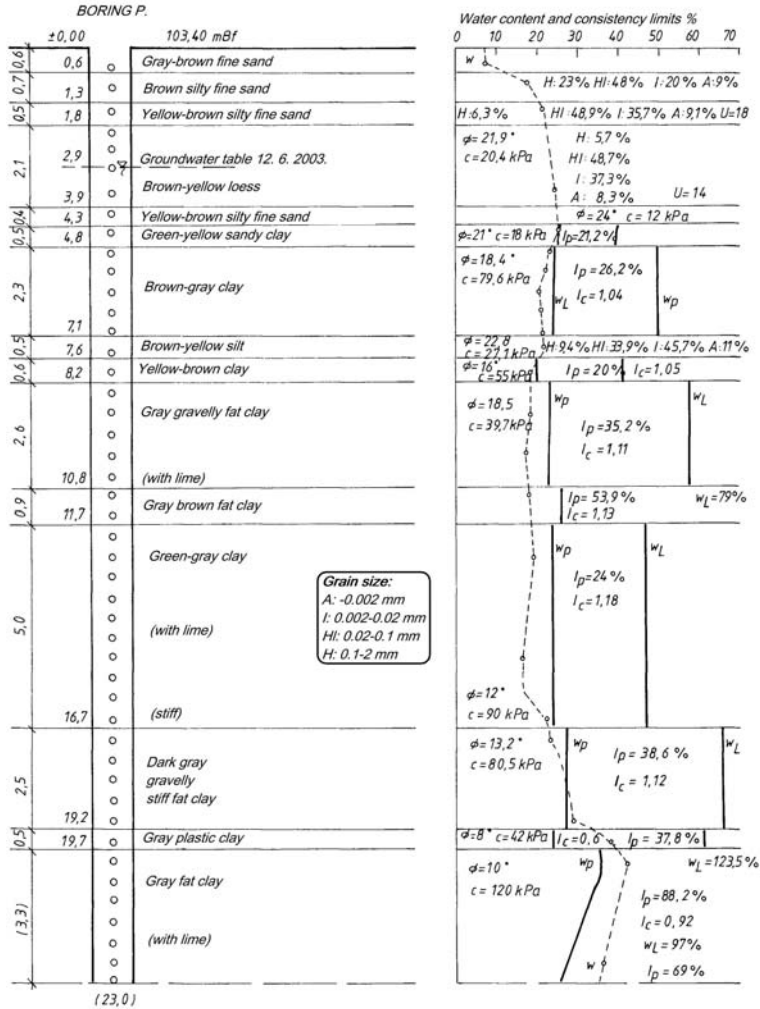
Fig. 7. Deep drilling

We detected the seeping of low intensity on the surface of the Pannonian clay in the presented drilling; then, after having finished the drilling 60 hours later the level at rest of the underground water took place at 3.9 m depth. Later came also the turn of deepening a drilling with 23 m depth in the moving area at the bank (see *Fig. 7*). It can be seen that the drill proceeded transversely the loess down to 4.3 m, under which the medium and rich clay strata followed. The clay was in a relatively hard and good condition, however, the sandy sludge above it and below the underground water had a soft and disadvantageous consistency. Here, we reached in 19.2 m depth the light gray coloured plastic rich clay, then in 19.7 m depth the dark gray very rich ( $w_L = 123.5\%$ ,  $I_p = 88.2\%$ ) Pannonian clay, the motion of which can be just excluded.

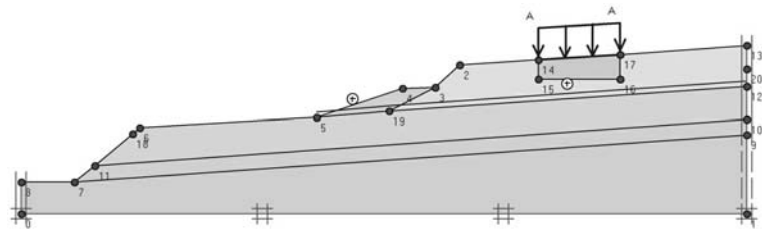
Fig. 10. Slope model

Since the possibility of development of both of sliding plane types could also be rendered probable according to the ‘traditional’ calculations, one near the surface and another deeper one, we examined the stability question by means of the Plaxis program; that means we modelled the section tested on the preceding, considered critical on the basis of motions, by means of computer-aided finite element test. In the course of the calculations we took into account the soil physical characteristics given in *Figs. 8* and *9*. *Fig. 10* shows the slope model.
