Floor Slabs Which are Frightening From Underneath, But Following Minor Repair Repeatedly Durable

Tamás K. Simon

Abstract

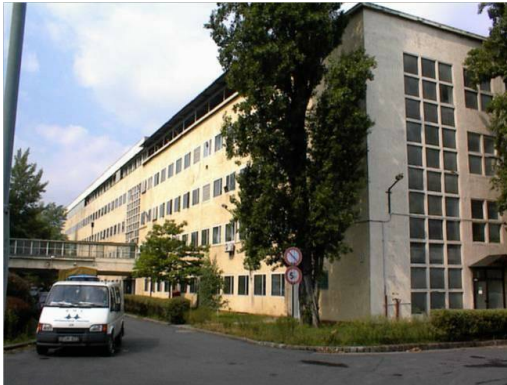
Fig. 2. The building in which the discussed failure occurred

At that time the industrial activity was ceased from the building, only the offices were functioning. One morning, when the cleaning lady has finished her task and closed the door behind her of one of the offices, heard a big noise from inside. As she reopened the door the picture of the ceiling on Fig. 3. appeared for her.
