Integrated Approach for Post-fire Reinforced Concrete Structures Assessment

RESEARCH ARTICLE

On the evening of November 16, 2013, fire spread through a Reinforced Concrete industrial warehouse on the outskirts of the city of Cagliari (Italy). Due to the fire, which lasted approximately 8 hours and was extinguished principally with water, the central part of the building and its load-bearing structure were damaged.

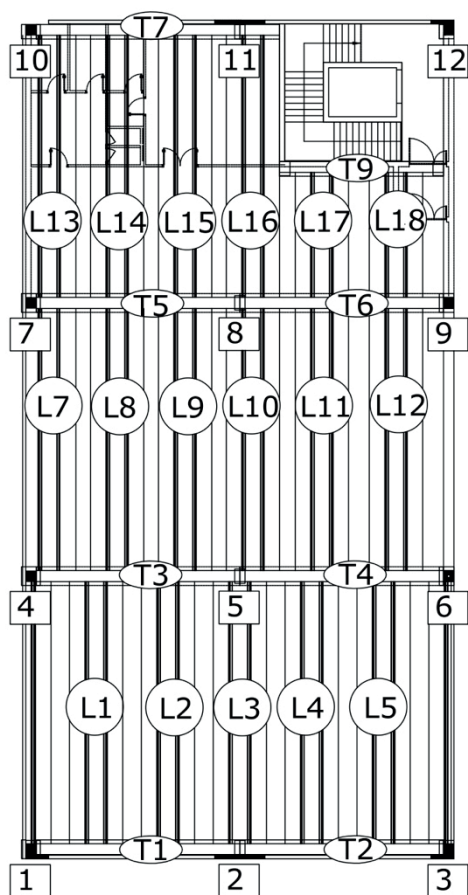
Fig. 8 Plant view of the fire area on the ground floor.

Lateral columns labelled 4–6–7–9 present the most evident damage: it seems that they have been hollowed out from the fire-exposed side towards the core, probably due to convective motion generated during the fire. Concrete belonging to these columns was expelled, leaving a visible void, while reinforcements are still present although damaged. The contrast with the neighbouring fire-resistant wall is patent as well, and is depicted in both Figure 7 and Figure 9, where it is easy to note that column 6 is severely hollowed-out. On the contrary, perimeter columns 1–2–3–10–11–12 were less exposed to the fire, and negligible visible damage was recorded.

Central columns 8–5 present a completely different situation: the superficially-burned plaster exhibits great characteristic roughness, and its colour tends towards greyish white. Spalling of concrete occurs infrequently in these elements.

The bottom part of the T-shaped beams (labelled with T in Figure 8) was exposed to the fire; indeed, the upper part was protected by the slab and by the omega-shaped beams. In particular, beams T3–T4–T5–T6 seem to have suffered the most important damage, with concrete spalling and desolidarisation of prestressing tendons.

Actually, it separates the fire area from other areas, providing sufficient thermal insulation. The left wall (referring to Figure 8) was heavily damaged, with many cracks and incumbent collapse, as shown in Figure 9a. The right wall, shown in Figure 7 and Figure 9b, has lost part of its plaster, but there are no visible cracks.

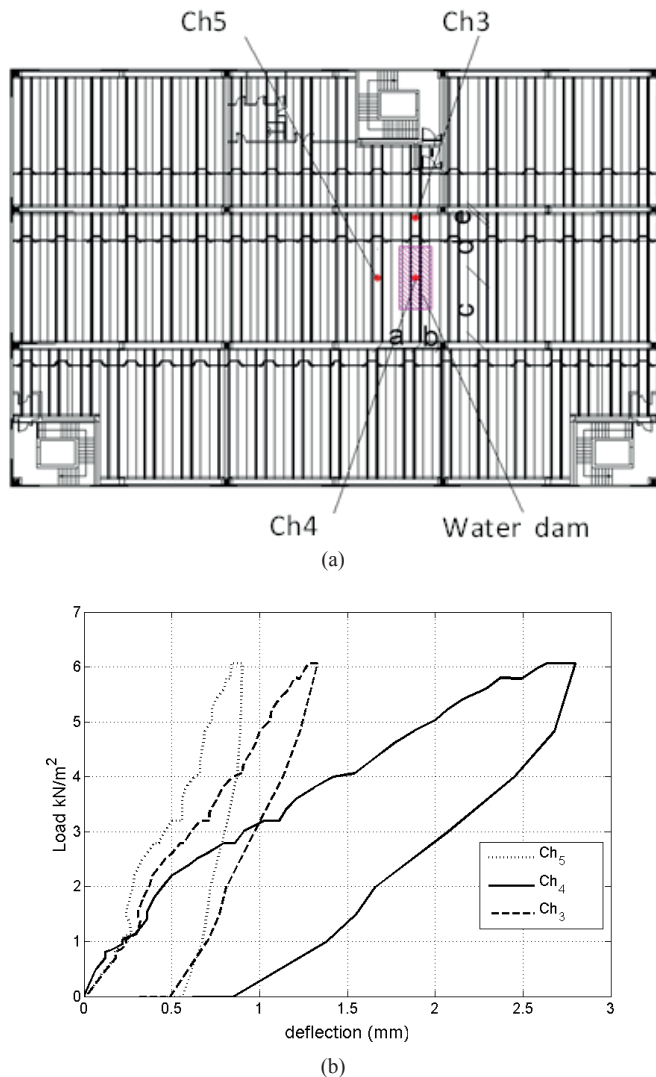
Fig. 10 (a) Positions of displacement transducers and the water dam during the loading test, $a = 3.55$ m, $b = 2.27$ m, $c = 6.30$ m, $d = 5.80$ m, $e = 0.50$ m. (b) Load-displacement diagrams for the three transducer recordings.

The RC slab supported by the beam tested plays a structural role which is not negligible; this is proven by the deflection recorded by Ch5. Stress distribution due to this effect also reduced beam deformation during the fire.

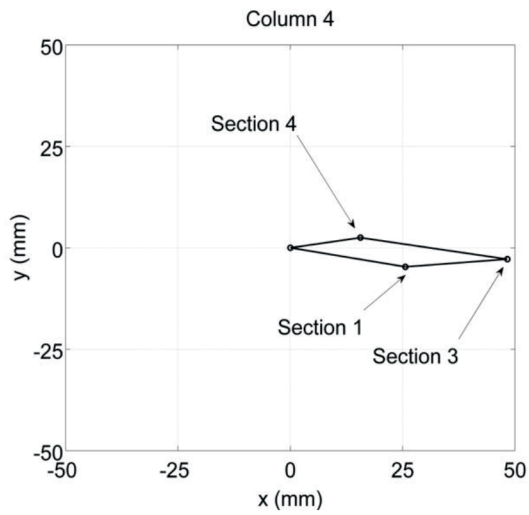
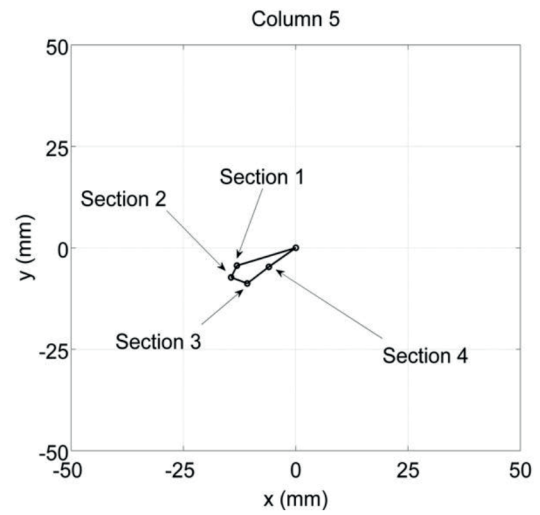
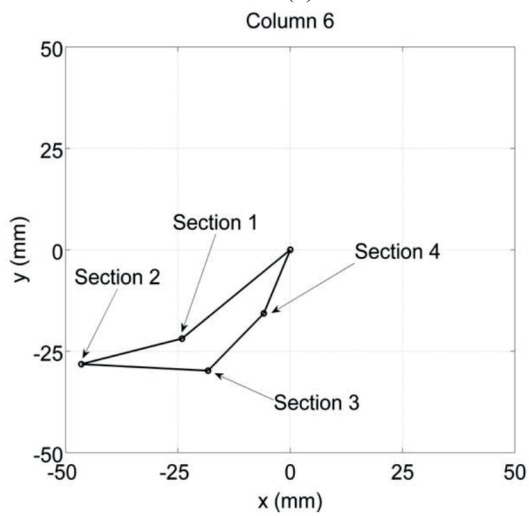
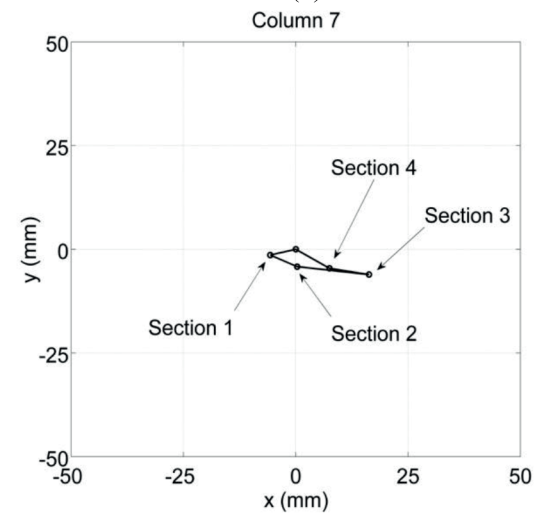
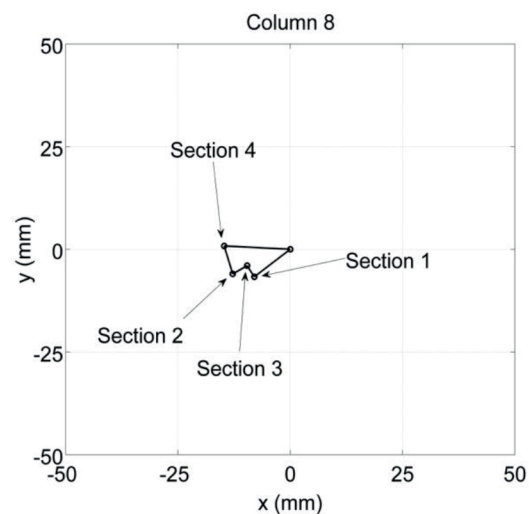
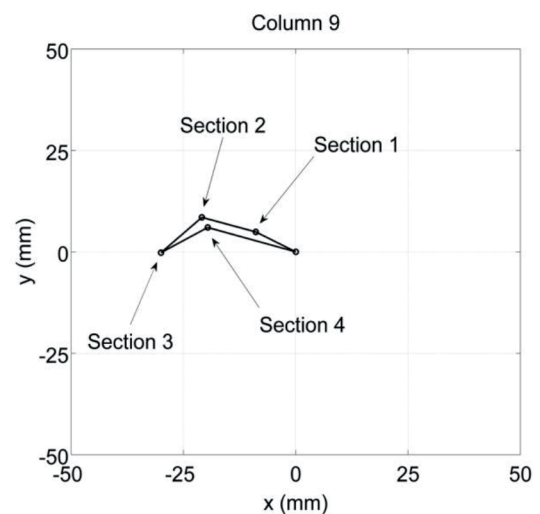
Fig. 12 Centre-of-gravity position of column cross-sections at different heights.

Only columns 4 and 6 show a SD x higher than 10 mm, while in all other cases, it is unlikely to find values greater than 5 mm. These centre-of-gravity position variations represent a small fraction of column height, in addition, as stated previously, they are probably due to local damage of the cross-section and not to real displacement of the column, see Figure 13. Furthermore, after a complete section restoration with new concrete, variations will be reduced to completely negligible values.

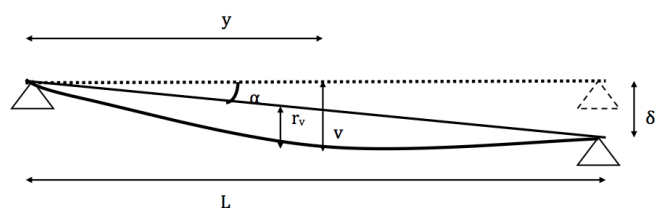
Fig. 14 Scheme of beam constraint displacement.

The fire also damaged the whole central area of the ground floor, and transversal T-shaped beams (labelled with T code in Figure 8), simply supported by the columns, were deformed and modified. Transversal omega-shaped beams (labelled with L code in Figure 8), supported by the above-mentioned T-shaped beams, consequently experience constraint displacement δ , which determines rigid rotation α , as schematised in Figure 14.

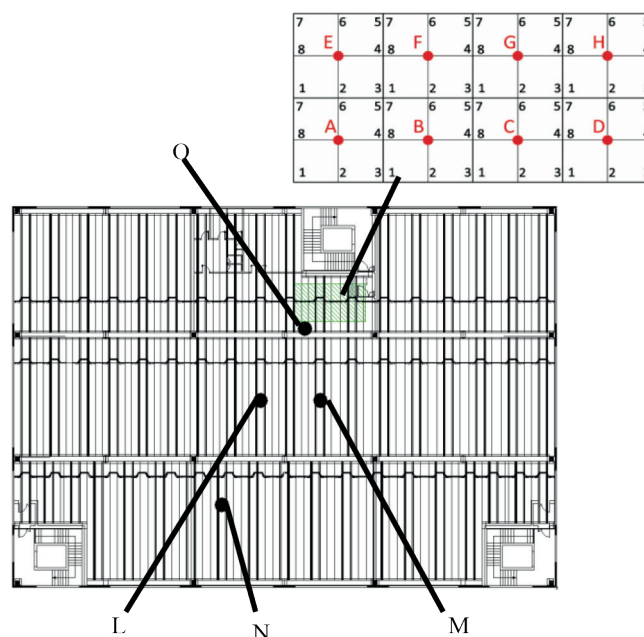
Fig. 16 First floor slab Sonic Tomography and ultrasound test positions.

From the data reported in Figure 17, it is clear that the most highly damaged area corresponds to left points A and E, which present the lowest speed (2000–2400 m/s). Indeed, it is well known (see [21]) that damage significantly reduces the speed of sonic pulses. On the other hand, points H and D present the highest speed value (3800 m/s) and are located in a corner of the slab, near the stairwell. The latter points were probably less exposed to the fire and consequently reached lower temperatures than the ones (points A and E) located in the centre of the slab.

Furthermore, four cylindrical core samples of 6 cm diameter were taken from the slab at points represented by the circular black spots in Figure 16 by means of an HILTI corer DD 130. An ultrasound direct test was performed on these cores, obtaining the results presented in Table 3. These results confirm degradation of the central part of the slab corresponding to the area around beam T4.

Slab core (points O,N,L,M, see Figure 16) compressive strength test results confirms the difference in mechanical

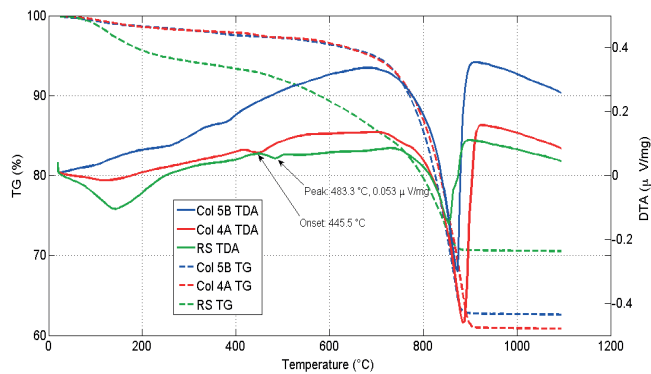
Fig. 24 Multi-plot of TG-DTA curves of selected samples (COL 5B, COL 4A (Sp a) and RS, see Table 9).

Table 10 reports some important diagnostic features of fire-affected concrete, determined by XRD and TG-DTA. This table also shows changes in mechanical strength at different temperature ranges. X-Ray diffraction patterns of the most highly-altered samples consist of calcite and dolomite. Calcite, dolomite, portlandite, ettringite and anhydrous calcium silicates and calcium aluminates were recognised in the RS sample.
