Historical-Critical Knowledge and Restoration Projects in Architecture: the Case of St John the Baptist in Castelvecchio Calvisio (L'Aquila, Italy)

Abstract

2 St John the Baptist at Castelvecchio Calvisio (Aq)

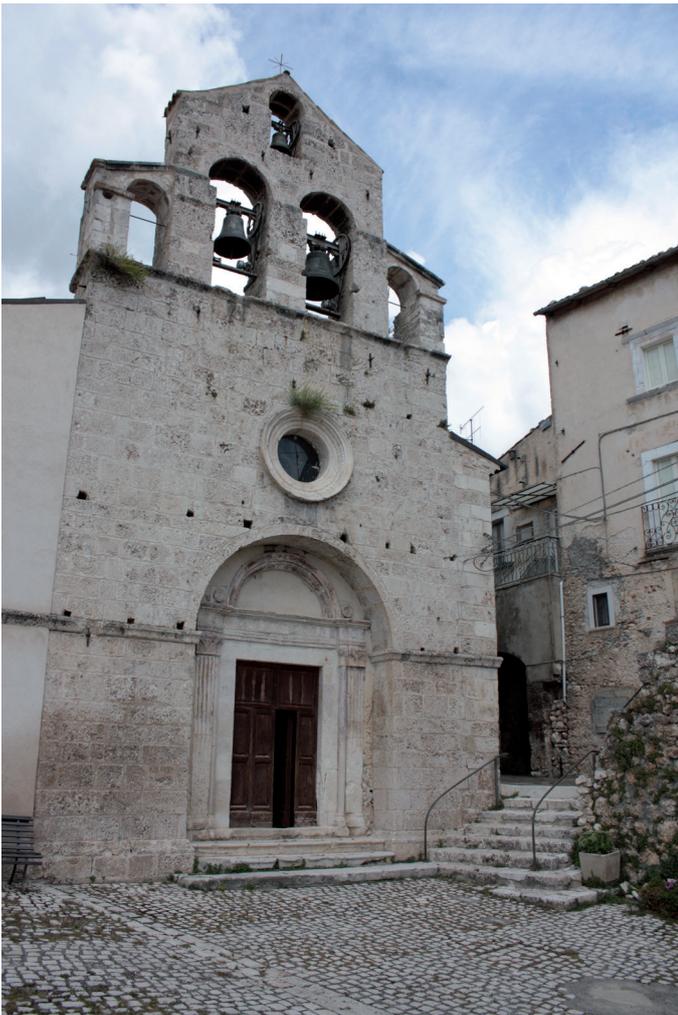
Fig. 1 View of the entrance façade.

significant damage to the church, except for some minor collapses in the side arches of the *vela* (‘wing’ type) bell tower at the front, which were promptly rebuilt (Fig. 1); this was probably due to the recent seismic improvements made at the top of the perimeter wall. By contrast, the earthquake had more serious consequences in the area, exacerbating already precarious conditions caused by abandonment, which is in part responsible for the conservation problems shared by other smaller historical centres (Crisan, Fiorani, Kealy, Musso ed., 2015).

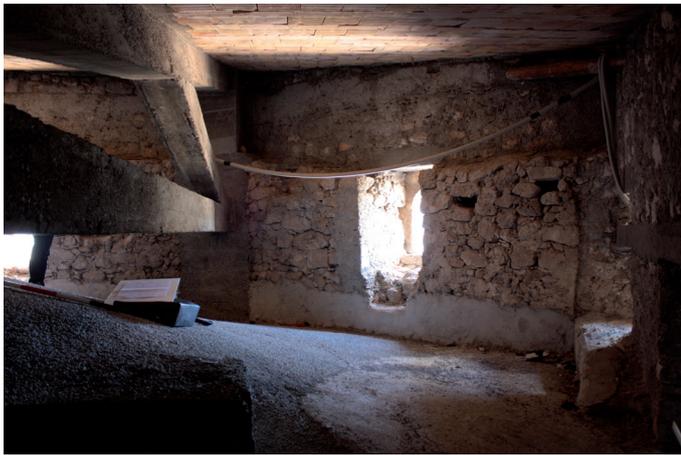
Fig. 4 View of the attic space above the final span of the central nave.

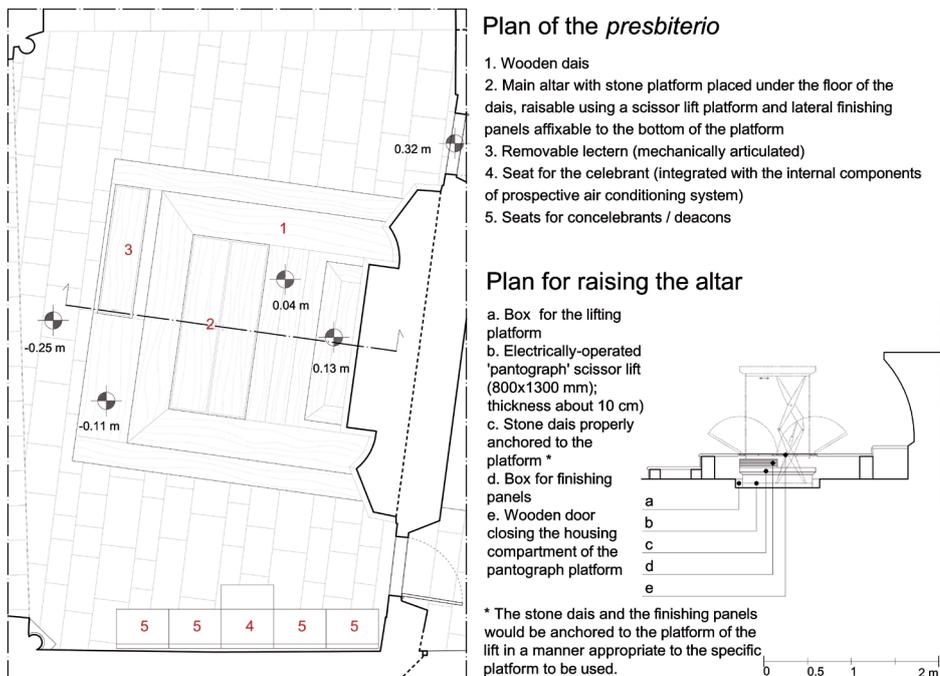
Fig. 5 Proposal for rearrangement of the presbiterio.

By contrast, if the recognition of a consolidated seventeenth century articulation should avoid interventions to restore earlier phases, it is precisely this internal spatial identity that requires the development of a different solution for the *presbiterio* (chancel). The current solution for the chancel, although complying with the requirements of liturgical adaptation¹², partially obscures the view of the baroque altar, impacting on the perspective of the space due to the central placement of that same altar. The introduction of elements «*not fixed, or 'mobile', carefully designed and defined*» (CEI, 1996, point 16) would allow the restoration of that view, consistent with occasional use of the space itself (Fig. 5). Partial distributive modifications and changes to intended use would guarantee better conditions for conservation of existing work in the building, as well as a more rational use of the different spaces. This would also take into account the specific requirements of the asset by the local community¹³, and the intrinsic characteristics of its

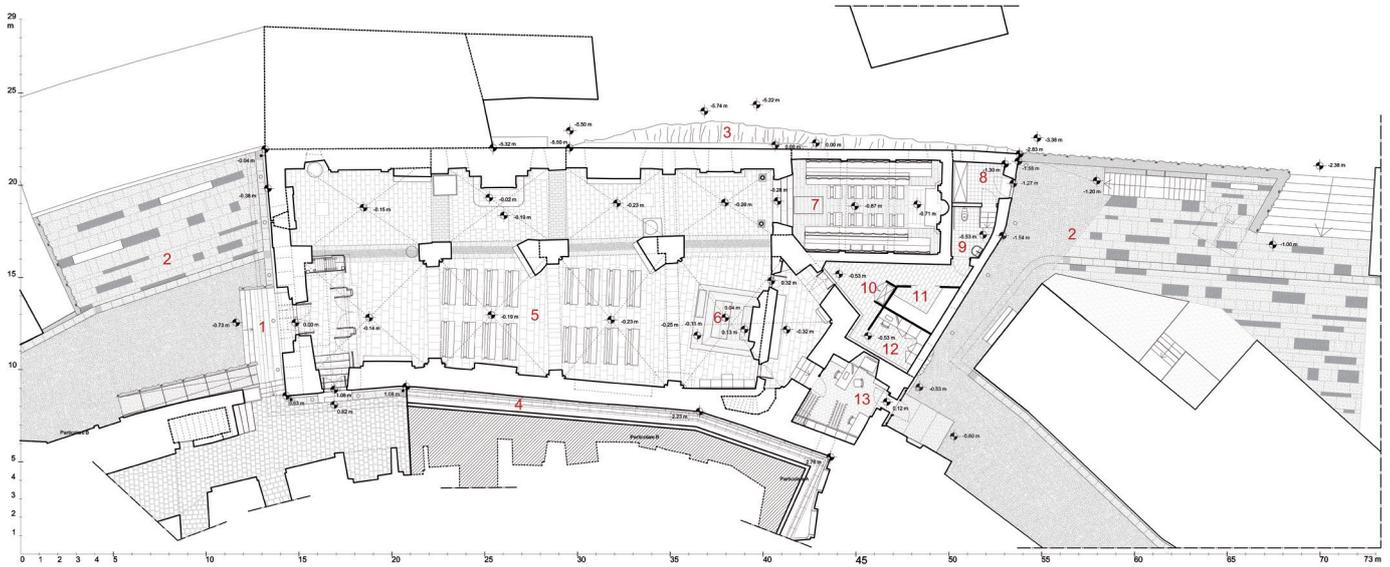
Fig. 6 Plan with an indication of the intended uses and the major actions. 1) Reconfiguration of the main entrance, 2) organisation of the outbuildings, 3) removal of the cement superstructure and stabilisation of the rocky outcrop, 4) perimeter gap, 5) disassembly and reassembly of the interior flooring of the church and improvement of technical equipment, 6) reconfiguration of the *presbiterio*, 7) side chapel, 8) location of technical equipment, 9) toilets, 10) sacristy, 11) church equipment storage, 12) reserved space, 12) parish archive/office.

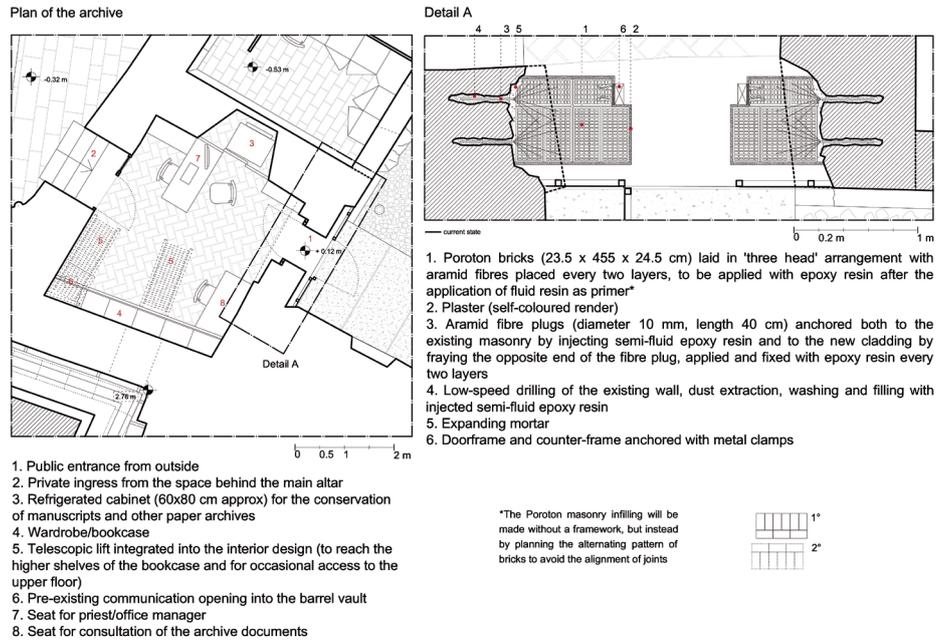
Fig. 7 Project plan for the ground floor of the western tower and details.

The western tower, fundamental to comprehending the sequence of the church's early construction history, and used until the nineteenth century as an ancillary space, requires reintegrating in its entirety into the context of the church, to which the upper storey of the tower belongs. The ground floor of the tower is currently used by a private garage and the door that led into the area behind the main altar was blocked up probably after the construction of the new sacristy; the vault structures still retain the passageway connecting the two levels of the tower¹⁴ which is accessed by a well-documented wooden stairway, now missing. The reopening of the blocked door would allow direct access to the service rooms above, while the current entranceway (from outside), properly resized for the improvement of nearby structural conditions, could be used for public input. The space would lend itself to accommodating an office and the parish archive due both to its size and distribution characteristics and to its historical-constructive importance, which sets it apart from the other parts and accessories; among other things, it retains the surviving flooring in herringbone pattern brick. From the ground floor of the tower, it is possible, if necessary, to reach the top level by restoring the vertical connection through the aforementioned opening in the vault using movable stairs integrated into the interior design of the archive (Figs. 7-8).

been well planned, it would be possible to install a system of water-filled floor radiators. Conversely, to prevent compromising the brick floor of the west tower, a radiant skirting board could be partially integrated into the fixed decor of the parish office; for the modest paper archive, finally, it would be sufficient to install a refrigerated cabinet, placed conveniently into the existing recess in the southern wall (Fig. 7).

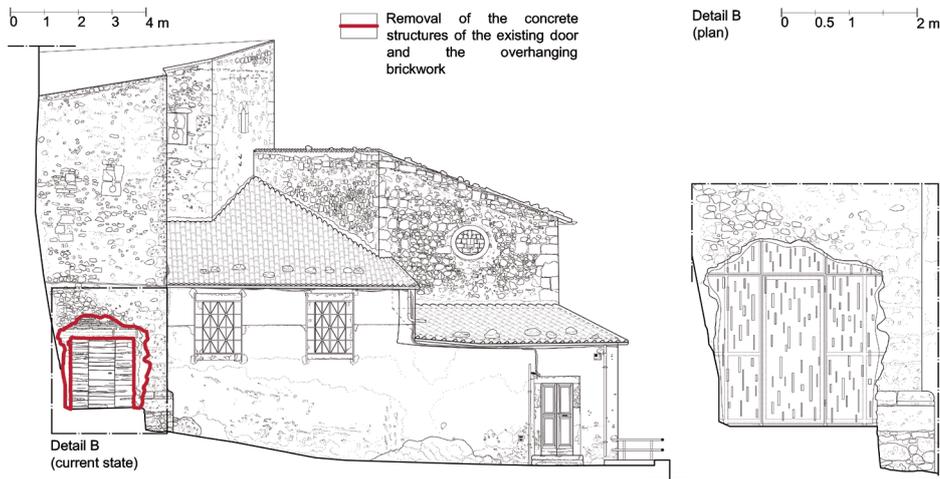
Fig. 8 Current state and project details of the western facade. The external closure of the new opening, obtained from redimensioning the existing entranceway, will be finished using 'Corten' steel plates. These will be cut with laser technology and mounted flush with the external face profiles with a stainless steel box; the external plastering will be limited to new 'poroton' bricks, recessed to be flush with outer wall, leaving visible a 'trimmed' profile resulting from the removal of the cement door jambs.

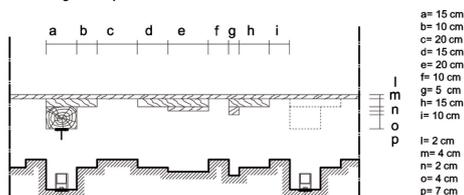
The concrete partition walls planned for the churchyard and public space behind the oratory can be achieved by modular form casting. Each module (1.2m) is equal to the distance between the metal uprights mounted in the deeper recesses of the wall.

The shape of the visible surfaces will be obtained through various protrusions conforming to the shape of the wooden forms, to be carried out according to the plan.

The colour and material finish of the new concrete walls will be derived from the use of white cement and an aggregate of medium grain size obtained by mechanical grinding of the local stone used in the façade. The correct amount of colours and aggregates added to the concrete mix will be obtained by means of test samples.

The highlighting of aggregate on the visible part of the wall will be ensured by decommissioning the moulding after 20 days and jet washing the exposed surface. Appropriate preliminary tests will determine the particle size to be used; the use of a medium-size aggregate (0.5 < diameter < 2 cm) should mitigate the rigidity of geometric shapes by giving an irregular profile to the linear edges of the recesses and protrusions.

Fig. 9 Technical aspects of new external reinforced concrete partitions.

A new design for the main entrance would also allow accessibility to the church by the disabled, and would lend itself to better-managed access to the churchyard from *via della Chiesa*, from which there is access the churchyard itself through a gap in the city walls, close to the facade. A ramp from the churchyard could connect the current street level with a new landing at the height of the masonry base of the eastern façade. For the construction of the new masonry walls, materials and technologies could be used that ensure appropriate integration with the natural environment. The new walls could use the same breach in the limestone foundation and thus create a perfect reminder of the geo-morphological character of the terrace in which the churchyard sits; while at the same time the manner of execution could shape the geometric rigidity of the new walls (Fig. 9).

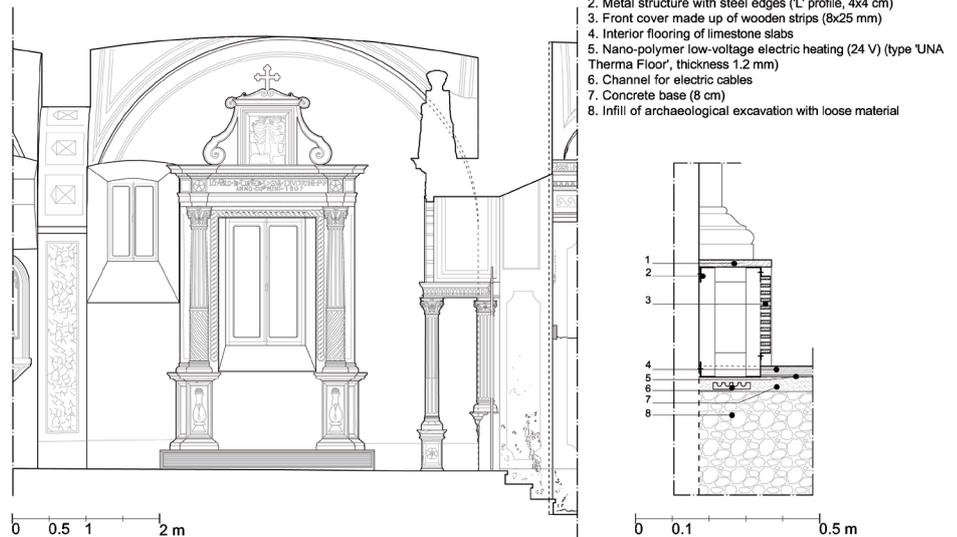
Fig. 10 Reintegration proposal for the predella of the altar against the south perimeter wall in the last recess on the left.

mentioned issues of geometric-distributive compatibility. The small space inside the new structure could then be used for the housing of junction boxes and other electrical components (Fig. 10). In any case, beyond the possibilities offered by new shapes, which could be added to or reintegrated in consideration of principal formal and architectural values, the existing seating and channelling should be verified prior to planning, should be reused in the first instance.

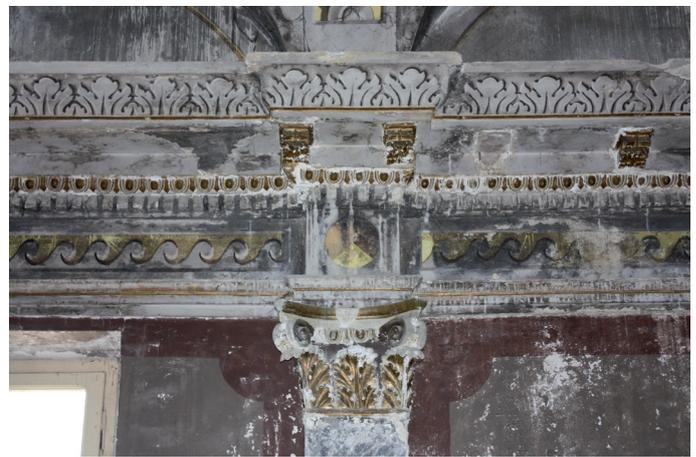
Fig. 11 Details of the internal southern wall of the former oratory of Our Lady of Suffrage.

The degradation phenomena detected on the painted plaster and stucco on the frames and capitals appear to be due to a combination of physical-chemical mechanisms and the mechanical disintegration of the materials (gaps, exfoliation and erosion of the paint film, disintegration, and efflorescence). In addition, there is damage caused by lack of maintenance (a lack of brackets for the gilded wood frames) and inappropriate reintegration of the missing parts (inappropriate restoration of gaps and damage in the paintings). With consideration after preliminary cleaning, the intervention will be aimed at the consolidation of the media and of the plastic components of the

architectural order, as well as the final treatment in undertones of the incomplete geometric decorations and the reintroduction of missing components (Fig. 11). The manner of execution, as ever not always easy to verify, would in this case also be derived merely from theoretical reflection, according to which a slight distinguishability could be implemented. In order for the newly-constructed corbels, replacing those that have been lost, to appear similar to the originals in terms of size, shape and final gilding, they will also have similar decorative motifs to those on the surviving elements; in particular the revival of acanthus leaves carved into the lower surface of the volute. Originally achieved using bas relief, this could be achieved by employing a different carving technique, for example the technique known as *a fondo incassato* (fully embedded); the 'simplified form' alone is not considered appropriate because of perceptual imbalances that could arise from a different play of light on the newly-integrated corbels and on the existing ones.
