# Experimental Investigation of Lateral Stability of a Longitudinally Assembled Girder Made of Precast Reinforced and Prestressed Concrete Parts

This research focuses on the lateral stability (LS) of a longitudinally assembled girder (AG), constructed for both economic and constructional purposes. The AG features a central precast prestressed concrete (PPC) beam, 34.175 meters long, extended by two precast reinforced concrete (PRC) beams, each 2.63 meters long, connected by bolted joints. A gap between the joints was filled with high-strength grout to efficiently transfer compressive stresses. The experimental study considered two types of imperfections: initial lateral imperfections in the AG and the initial tilt angle between the connected surfaces. Three tests (AG1-A, AG1-B, AG2) were performed using nondestructive loading with concrete blocks to assess LS. The first two tests were conducted on AG1, keeping the initial imperfections consistent but varying the preload on the bolts, while the third test used specimen AG2, which had greater lateral imperfection at the mid-span cross-section. Test results showed that, due to the high preload, the tilt angle imperfection had a negli

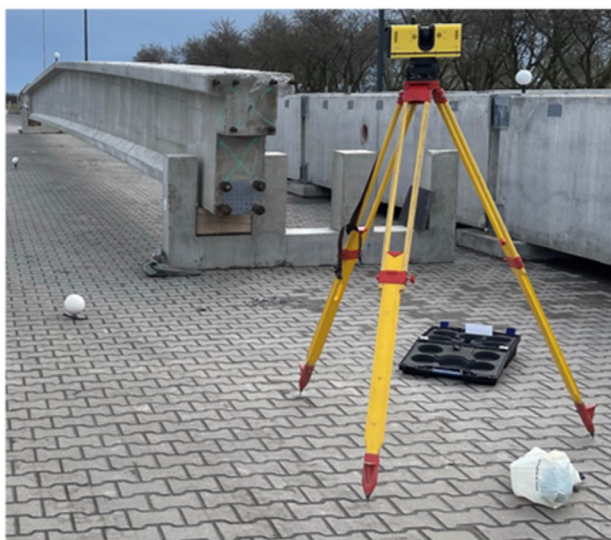
(a)

(b)

Fig. 4 3D laser scanning (a) laser scanner (b) point cloud results displaying the outer face of the girder before and after being fully loaded

a laser scanner device (Surphaser 400), as shown in Fig. 4; in Fig. 4(b), the green object represents the initial outer face of the girder before loading, while the red object represents the outer face of the girder after being fully loaded. By using AutoCAD software to compare the geometry of both objects, it becomes easier to measure the lateral deformation and twist angle during the loading process.
