ESTIMATING DIKE BREACH LENGTH FROM HISTORICAL DATA

Abstract

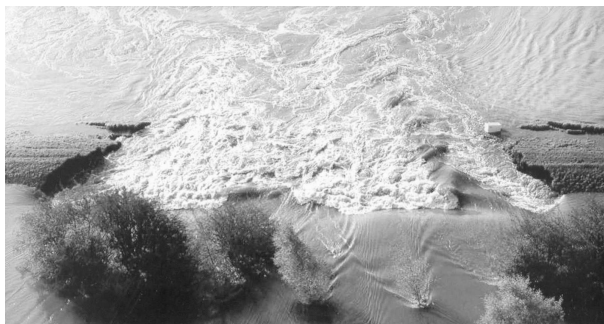
Fig. 1. Dike Breach in England November 2000.

Levee breaches have typical shape. A study of the photographs taken of dike failures that occurred in recent decades reveals several similarities in the shape of levee breaches. (*Figs 1 and 2*)

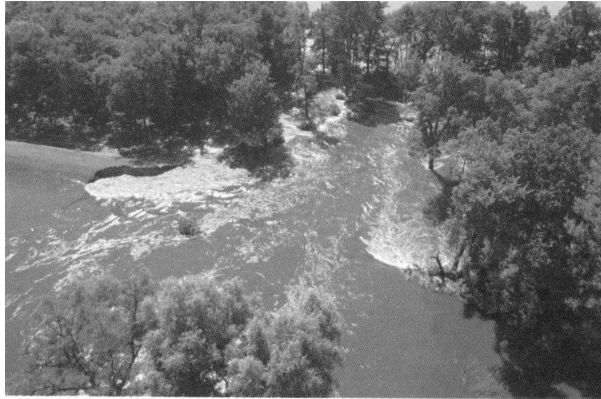
Fig. 2. Dike Breach at Oder river left bank at Frankfurt am Oder in 23 June 1997.

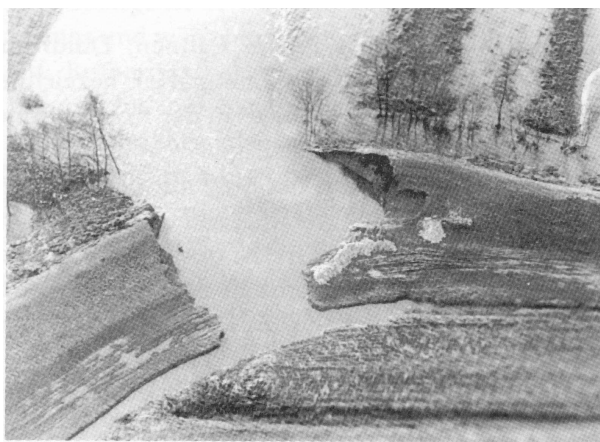
Fig. 4. Elba river left bank at Dorctersen in 3. January 1976 (Germany).

The remaining levee stubs are almost always vertical. Their direction is either perpendicular to the longitudinal axis of the levee or the opening narrows towards the protected side at a slight degree of inclination. (*Figs 4, 5, 6*)

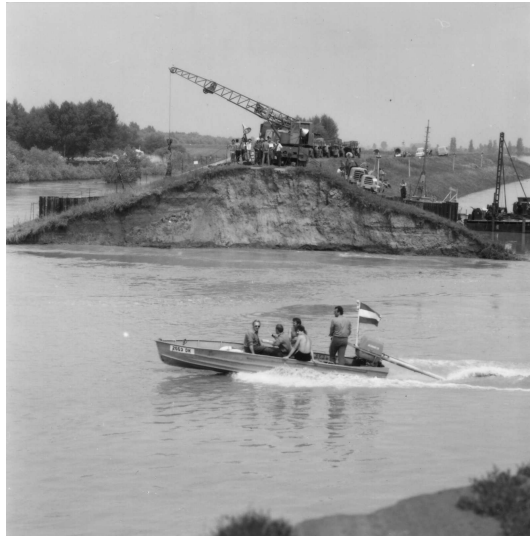
Fig. 5. Kettős-Körös flood in 1980 Hosszúfok dike breach (Hungary)

Scour pits would rarely erode backwards to show up on the water side. The Hosszúfok dike failure during the Kettős-Körös flood in 1980 illustrates this phenomenon, which subsequent studies proved to have evolved due to the presence of disperse soil. The scour pit advanced to reach the water side of the levee, which is why the pile-plank barrier constructed during the flood to close the breach had to follow an unusual large curve on the protected side. (*Fig. 13*) The dike failure on (*Fig. 14* also shows a scour pit that progressed to reach the water side on the left bank of the Tisza at Királyháza in the Ukraine in 1998.

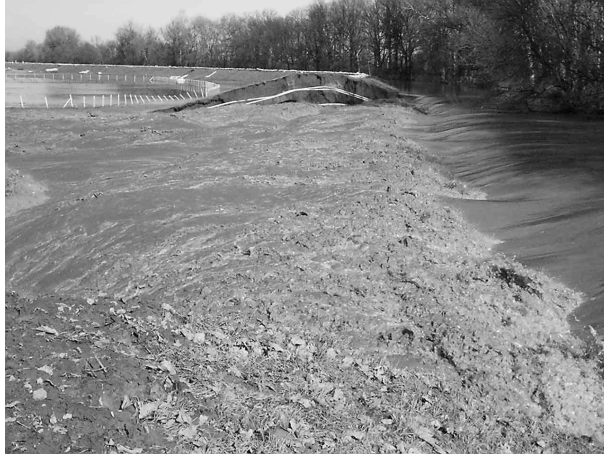
Fig. 6. Breach at Tisza right bank in 2001 (Hungary).

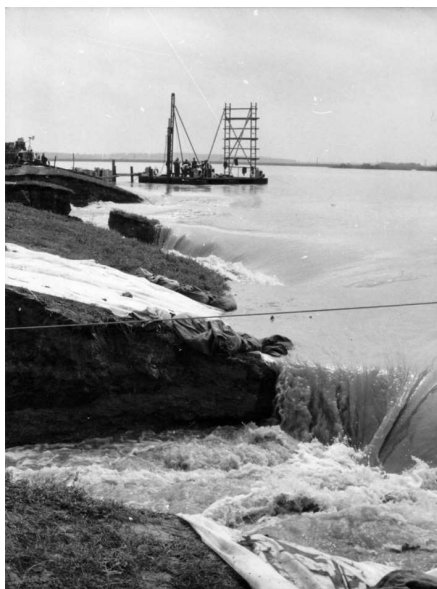
Fig. 8. Dike breach at Szeghalom in 1980 (Hungary)

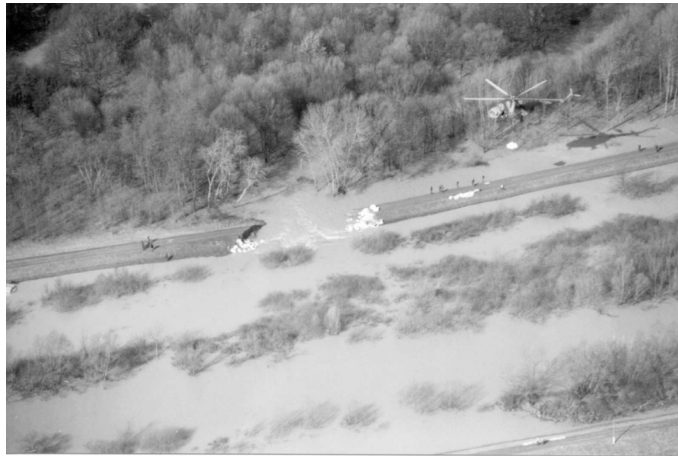
Fig. 10. Dike breach at river Túr left bank in 2001 (Hungary)

Occasionally, reducing the level of water on the water side is also possible. Two dike failures occurred on the left hand side of the Túr among unique hydrological conditions during the Upper Tisza flood of 2001. Although the level of the water was decreasing in the river itself, volumes of water were retained in the reservoirs

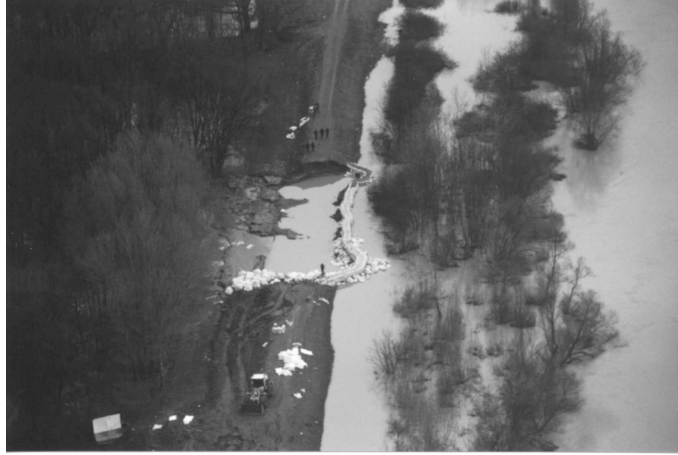
Fig. 11. Another dike breach at river Túr left bank in 2001 (Hungary)

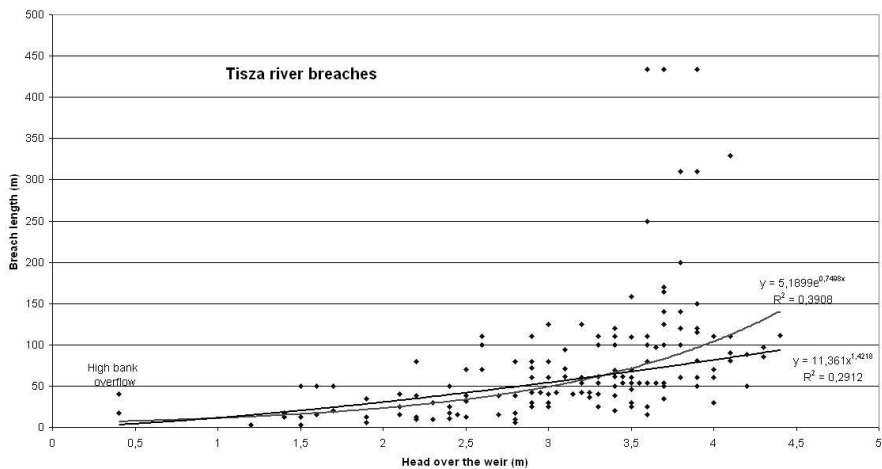
Fig. 12. Head over the weir and the length of a dike breach

Fig. 12 points out no more than the tendency of the relationship between the head over the weir and the breach length. As overflow height increases, so does the length of the levee breach but the correlation is sloppy in terms of both the power function and the exponential function (*Fig. 12*). That is probably due to the multitude factors that are at play. All in all, the results do not contradict the physical law that raising the height of overflow will increase the boundary shear of the water, which corresponds to the increase of the opening of a dike failure. The data show that the lower the height of the levee, the less variable the width of levee breaches.

The two points in the left hand side of *Fig. 12* indicate high ground⁴ overflows.

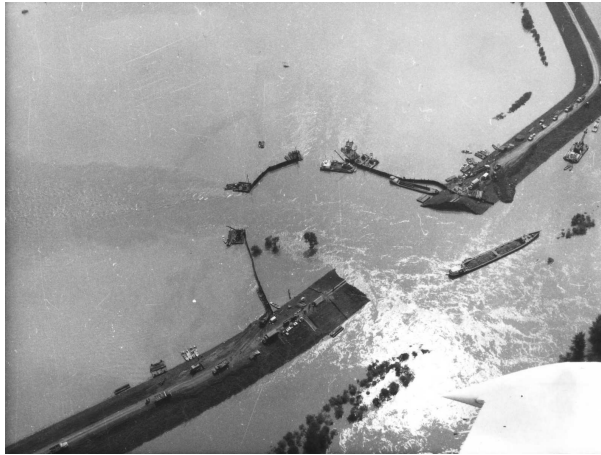
Fig. 13. Hosszúfok dike failure during the Kettős-Körös flood in 1980

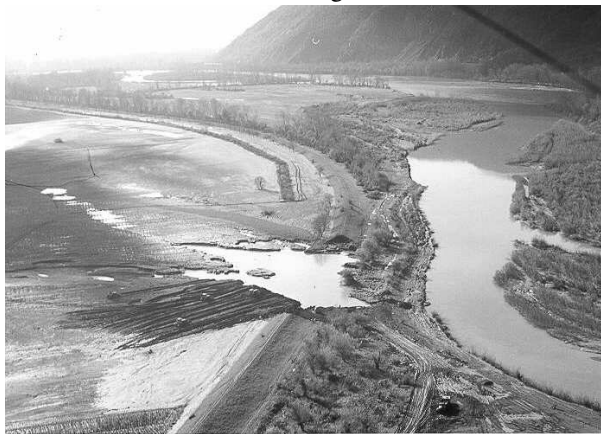
Fig. 14. Dike breach at Korolevo in 1998 November (Ukraine)
