STATISTICAL EVALUATION OF NUMBER AND DIMENSION OF DEFECTS IN STEEL BEFORE AND AFTER FATIGUE TEST BASED ON X-RAY EXAMINATION¹

István ZOBORY*, Tamás UNGÁR**, Anatoly SNIGIREV***, József GYŐRI* and Elemér BÉKEFI*

*Department of Railway Vehicles
Faculty of Transportation Engineering
Budapest University of Technology and Economics
H–1521 Budapest, Hungary

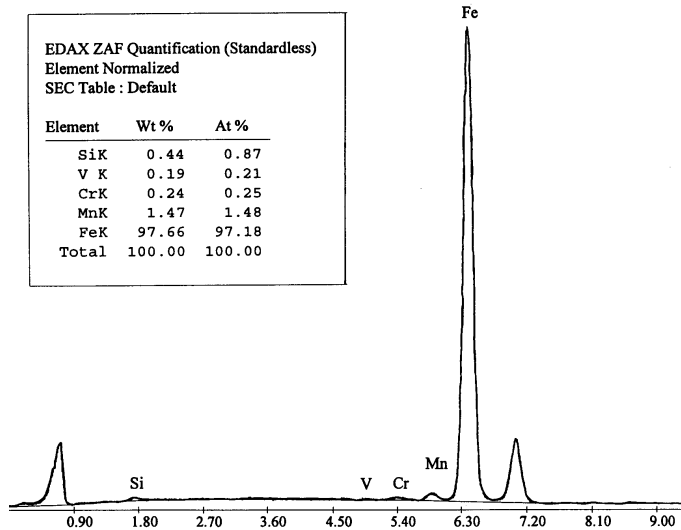
Fig. 1. Energy dispersion X-ray analysis map of the steel examined

On the horizontal axis the energy level is indicated in kiloelectronvolt, while on the vertical axis quantities proportional to the mass percent of the components being present are indicated. As it can be observed, the material examined can practically be considered as alloying-free steel, since it has only slight manganese

content, less than 1.5%, and practically negligible chromium, vanadium and silicon contents.

The material examined was a structural steel frequently used in vehicle components. In *Fig. 1* taken by energy dispersion X-ray analysis (EDS analysis) the content of the basic material (ferrum) and the alloying elements are shown.

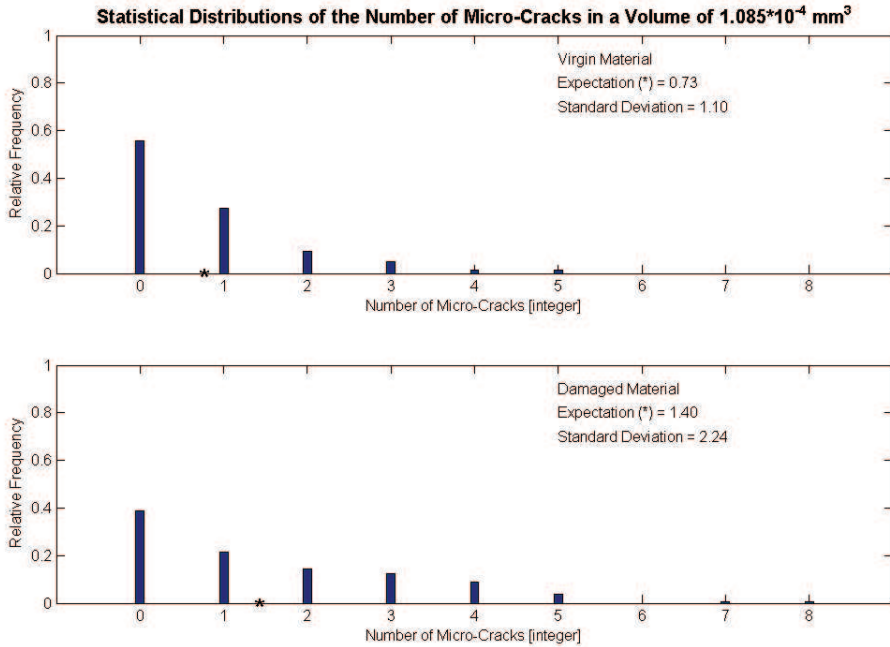
Fig. 4. Relative frequency histograms of the number of defects evaluated from the entries in the rectangles of the frequency matrices introduced for both materials in Tables 1 and 2

quency distributions of the number of defects given by the entries in the rectangles of the matrices introduced. Both for the virgin and for the damaged materials the relative frequency histograms are shown in *Fig. 4*. As it can be observed, the shape of the histogram belonging to the virgin material more or less follows the expected ‘Poisson rhythm’, while the histogram belonging to the damaged material visibly deviates from the ‘rhythm’ mentioned, since the medium part of the diagram shows certain stagnation character.

- The spatial distribution of defects estimated on the basis of a rectangular in space partition system of volume elements 0.0001085 mm^3 showed an approximate *Poisson rhythm* for the alloy-free steel examined in virgin state. The average defect density found for virgin material specimen was cca. $6800/\text{mm}^3$. In case of damaged material specimen processed out from the close neighbourhood of the fractured cross section, the approximate *Poisson rhythm* disappear, and the mean damage density was cca. $13800/\text{mm}^3$. This result means that the fatigue process leads to an *approximate doubling* in the number of defects recognizable in the framework of the applied X-ray technique and the subsequent statistical evaluation procedure.

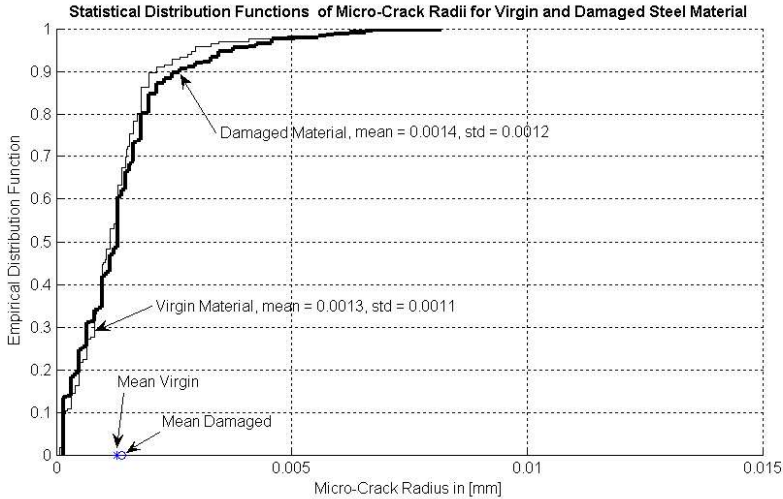
Fig. 5. Empirical distribution functions of micro crack radii for virgin and damaged steel material

For crack propagation simulation purposes it is more convenient to use the crack radii instead of the directly measured diameters. In *Fig. 5* the empirical distribution functions of the crack radii are shown for the virgin, as well as for the damaged material.

It is interesting to recognize, that the two empirical distribution functions do not show great deviations, though, in accordance with the expectations, the distribution function of the damaged material is slightly dilated to the right in the region crack radii of dimension 0.0015...0.005 mm.

- The defect dimensions were identified in the framework of a simple circular crack model. Surprisingly, the distributions of crack radii for the virgin and damaged material specimens showed only very small deviations. For

example the mean crack radius for the virgin material was 0.0013 mm, while for the damaged material the mean radius obtained was 0.0014 mm. The related dispersions were also in the close neighbourhood of each other, namely values 0.0011 mm and 0.0012 mm were experienced. All these leads to the conjecture that the load repetition in the bulk material (where no rapid crack propagation causing final fracture occurs) causes an increase in the number of recognizable cracks, but the dimensions of the initially existing cracks grow very slowly. The rapid crack, causing the final fracture of the test specimen is probably started from a ‘dominating’ initial micro crack having an initial radius in the close neighbourhood of the possible maximum crack radius values.
