Architecture 41/1 (2010) 9–17 doi: 10.3311/pp.ar.2010-1.02 web: http://www.pp.bme.hu/ar © Periodica Polytechnica 2010

# The adaptations of the true-to-form survey method

Balázs Halmos / Katalin Marótzy

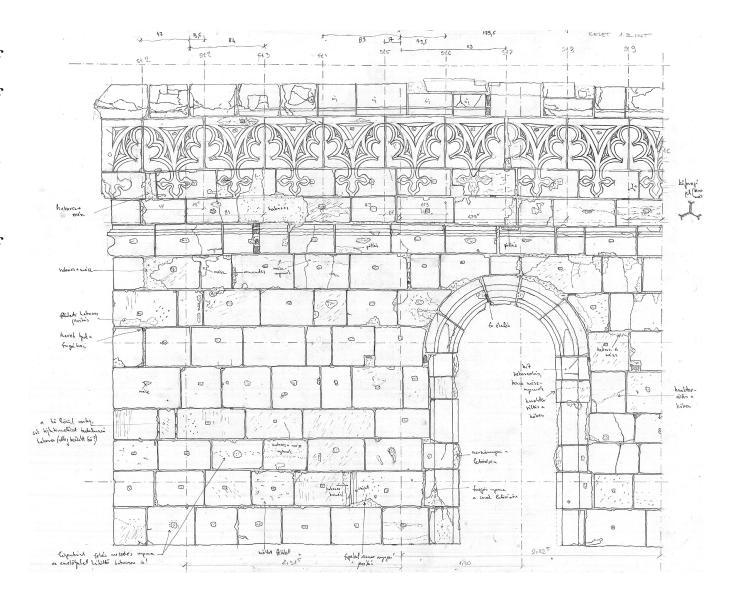
**Fig. 1.** Saint Michael's Cathedral in Alba Iulia South-western tower east facade 5th level (hand measurement, detail)

In case of the upper storeys of the tower the work was done according to the method applied by the Department earlier which is the processing carried out parallel with the measuring.<sup>7</sup> The measured data was recorded on separate segments on a scale of 1:20, constructed in pencil by those participating in the survey, and with the help of which the surface parts were depicted in a proper dimension. In each case, all corner points of every stone element have been recorded by precise measurement. Thus the survey reveals the derivation of the wall joints from horizontal and vertical, their exact thickness and its change. Besides the stone damage: clefts crumbling; mechanical damage and the visible marks of stone dressing tools including mason's marks and corrections; brick, tile, iron and wood elements were separately indicated. Replacements, wedges and wall-ties were also indicated on the drawings. The work carried out during the day was completed by the observations after dark when the documentation of the details visible only in a grazing light with the help of a torch (mainly the fainter mason's marks) was also carried out.

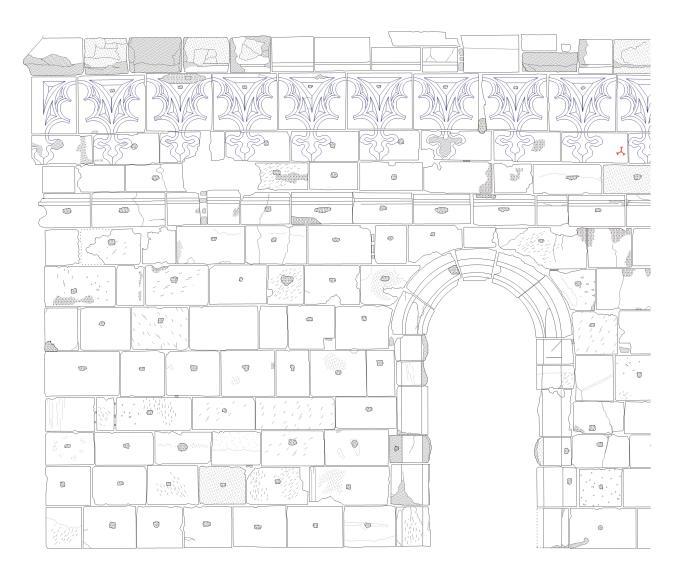
**Fig. 2.** Saint Michael's Cathedral in Alba Iulia south-western tower east facade 5th level (CAD documentation, detail)

by scanning and putting together the prepared drawings. At the client's request, a vectorized digital version has also been prepared of these with ArchiCAD software, redrawn line by line.

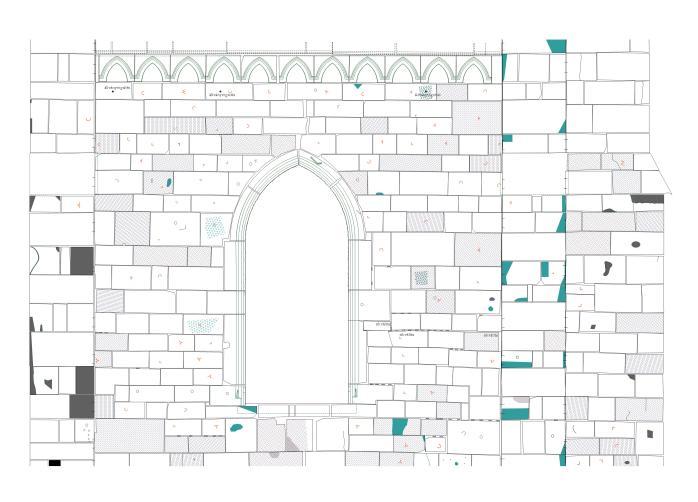
**Fig. 4.** Saint Michael's Cathedral in Alba Iulia south-western tower west facade 2nd level (CAD documentation, detail)

The post-processing of the lower part of the tower has been carried out with ArchiCAD software. In a phase of the construction we had the chance to check the drawings in progress on-the-spot and to correct certain measurement deficiencies. In

Compared to the survey of the upper part, the completed digital, vectoral drawing is graphically less true to nature, it contains more simplifications regarding the details, for example precise tracing of clefts, accurate contouring of fractures and chips. However these do not have an influence on the technical content relevant in respect of architecture and history of art. The drawing indicates the surface features such as material quality, dressing etc., in the forms of different fill patterns and by providing the necessary key to aid understanding.

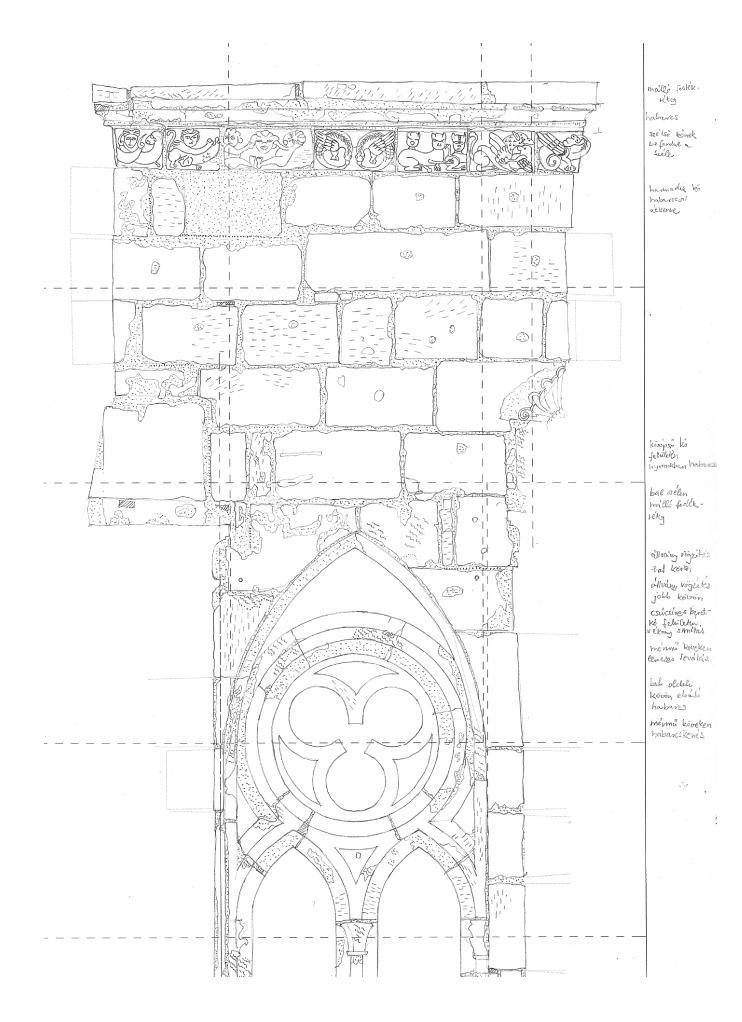
**Fig. 5.** Saint Michael's Cathedral in Alba Iulia Gothic chancel south facade, external 3rd section (hand measurement, detail)

Analysing the evidence from the previous measurements, a combined method has been applied for the external survey of the chancel. The first step, the geometry of the stones has been recorded by the "Steinbuch system" survey with the help of coordinates. This has been constructed as a cross hatching onthe-spot with the application of the ArchiCAD software by the colleagues. The possible inaccuracies, typically the confusion of the signs of the coordinates could be corrected immediately. The construction has been printed out to a scale of 1:20; similar to the tower; the details and material characteristics have been graphically recorded on these segments by hand. In the case of the chancel, the key has been established according to the features of the scene, taking care to make the signs and fill patterns different and easily drawable. Colourful, light dashed-pointed lines have been applied to the printed cross hatching therefore the digital pre-construction is distinctly visible for the drawer, however in the final state these are if the construction is precise, basically covered by the drawing. The documentation has been created by assembling the segments drawn by hand.

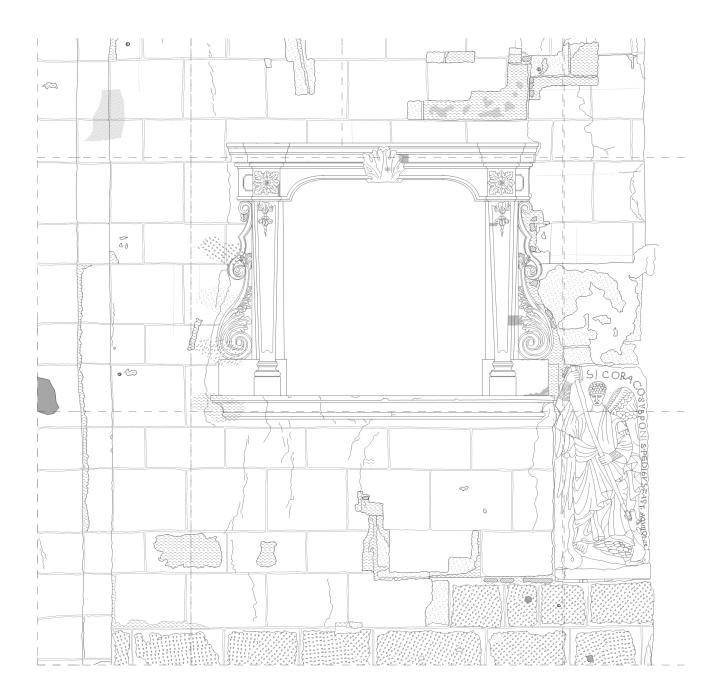
**Fig. 7.** Saint Michael's Cathedral in Alba Iulia Gothic chancel south elevation, internal 9th section (CAD documentation, detail)

Contrary to the previous experiences, extensive plastered surfaces have been found inside the chancel, the measurement applied in the case of the external part had to be modified. Instead of stones interpretable as closed cross hatchings, the corner points at the sometimes one centimetre thick wall joints carved into the coat of plaster, not the boundaries of the stony surfaces have been measured. The computer construction and the on-the-spot drawing have been completed as had been done before, however in this present case for the key, the recording of the different surfacings e.g. levelling and smoothing mortar, whitewashing, painting not the recording of the stones had to be taken into consideration. The segmental plane processing has been completed with part measurements carried out with the help of traditional manual methods. Besides the assembly of the drawn segments, the preparation of a vectorized, digital drawing has also been carried out in the course of the documentation, using and elaborating further the basic construction made on-
